Case Review – Grounding of R/V “AUBI”

U.S. Coast Guard Sector San Juan - Incident Management Division

Incident Brief - 15MAY15 - 0835

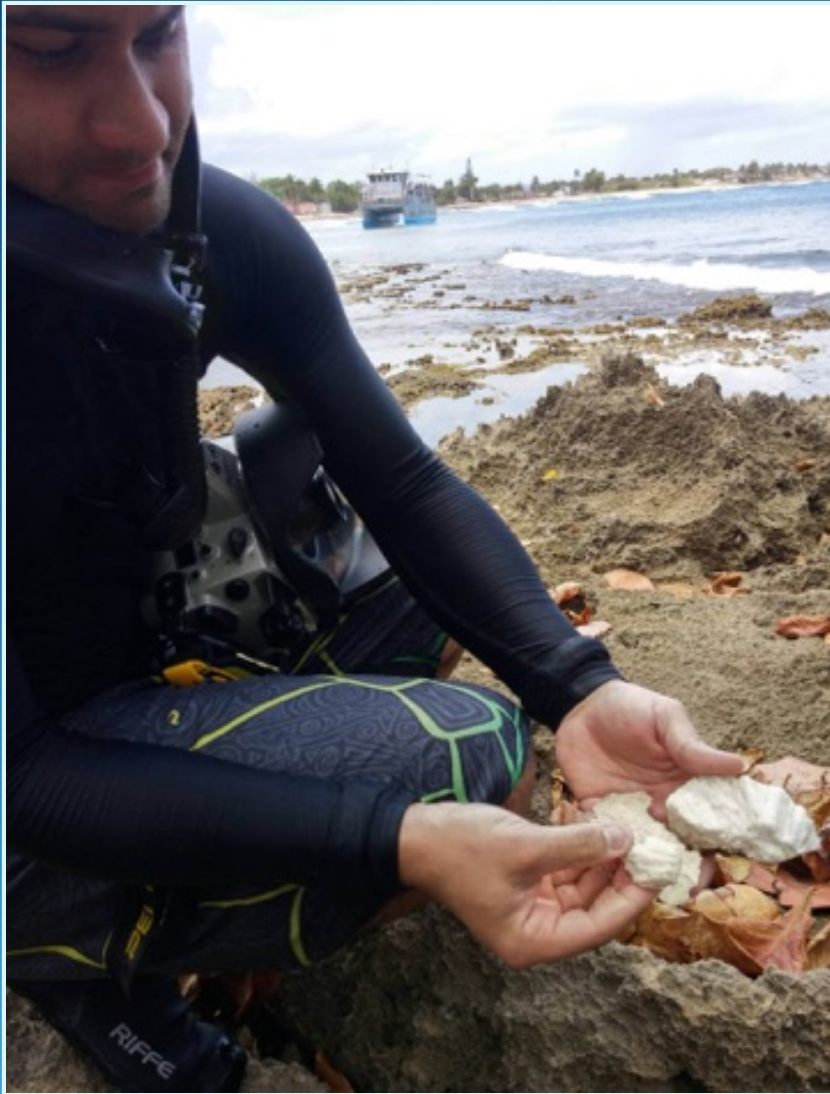
- Validated no signs of pollution.
- Found website for the R/V in bold lettering on bulkhead of vessel.
- Met with Barceloneta Police and DNER representatives for the Natural and Marine Reserves.
- Interviewed witnesses and confirmed time of grounding – 14MAY15 @ 2300.
- Met with Mr. Miguel Mercado (pictured), a volunteer coral reef conservationist. His photos showed the extent of damage to present Endangered Species.

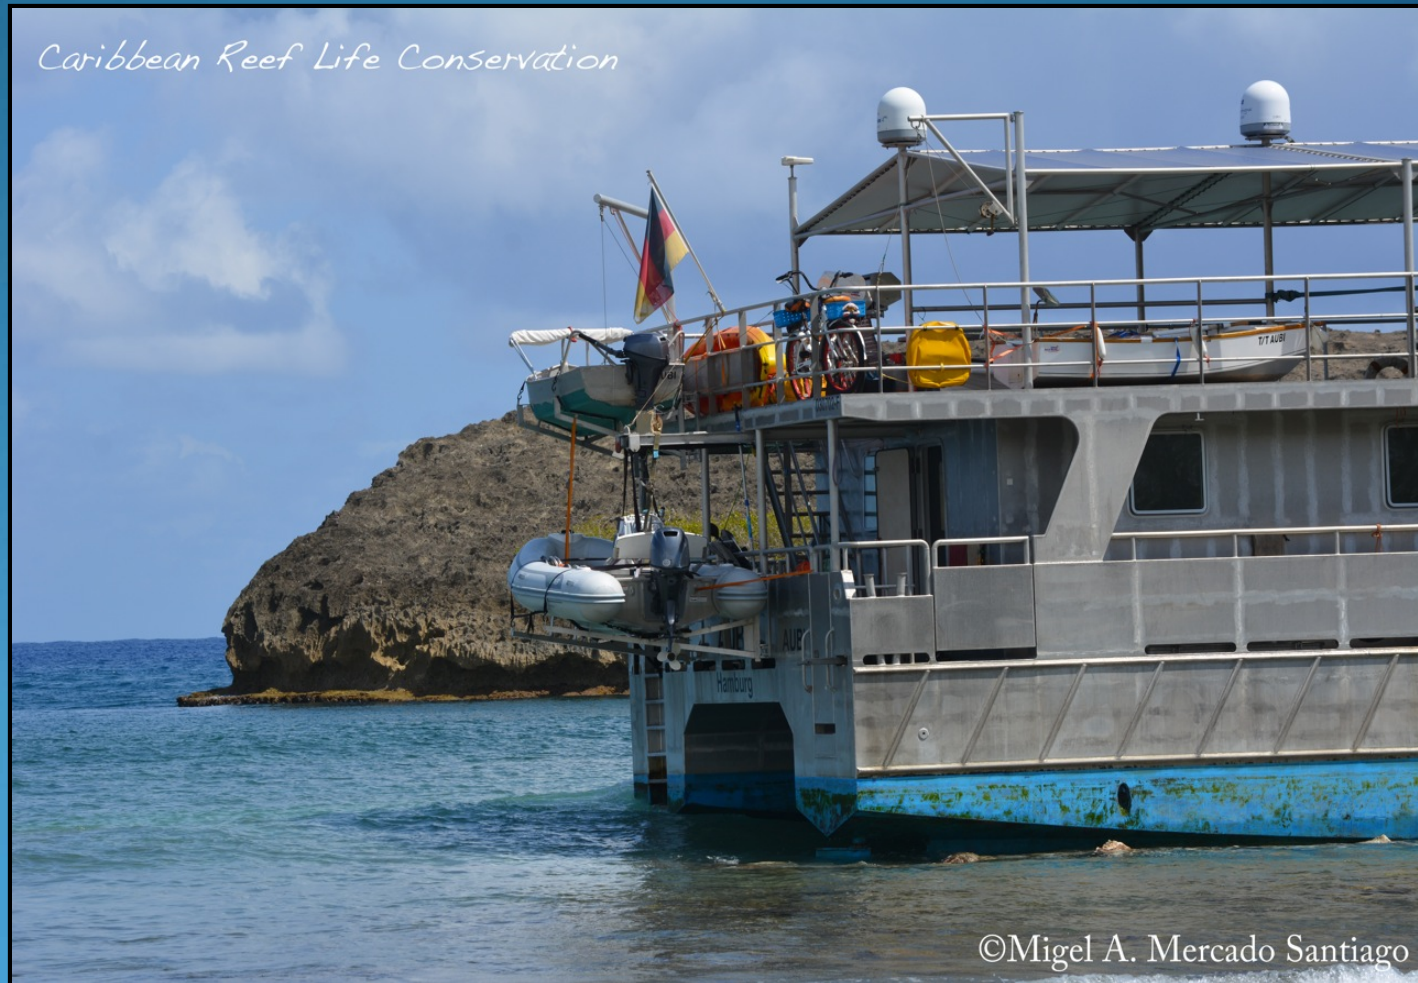
Caribbean Reef Life Conservation

An Endangered Species Consultation for Emergency Responses was completed and submitted by Sector San Juan IMD due to the possibility of damaging listed endangered species as a result of response activities.

The owner of the vessel was ordered to remove all fuel on board his vessel prior to conducting salvage operations.

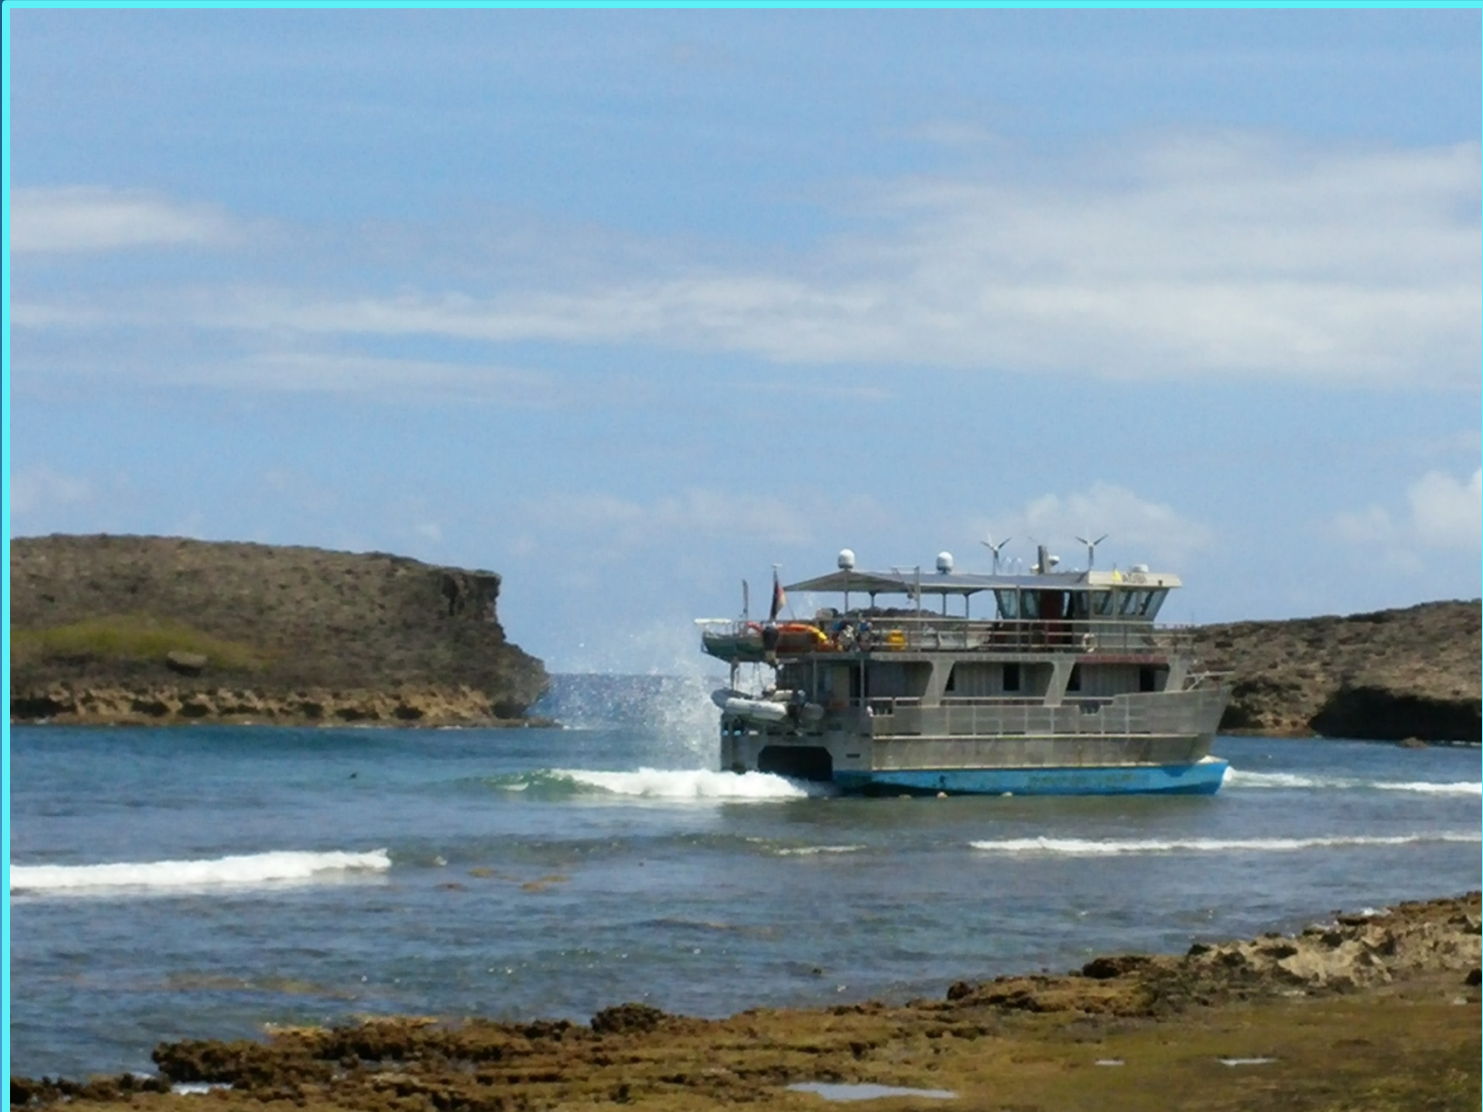
Increasing tide and wave action made for a stressful few hours prior to equipment arrival.
