South Jersey Ice and Cold Storage
Vineland, Cumberland County, NJ

EPA Emergency Response
June – August 2016

USEPA Region 2
Response and Prevention Branch

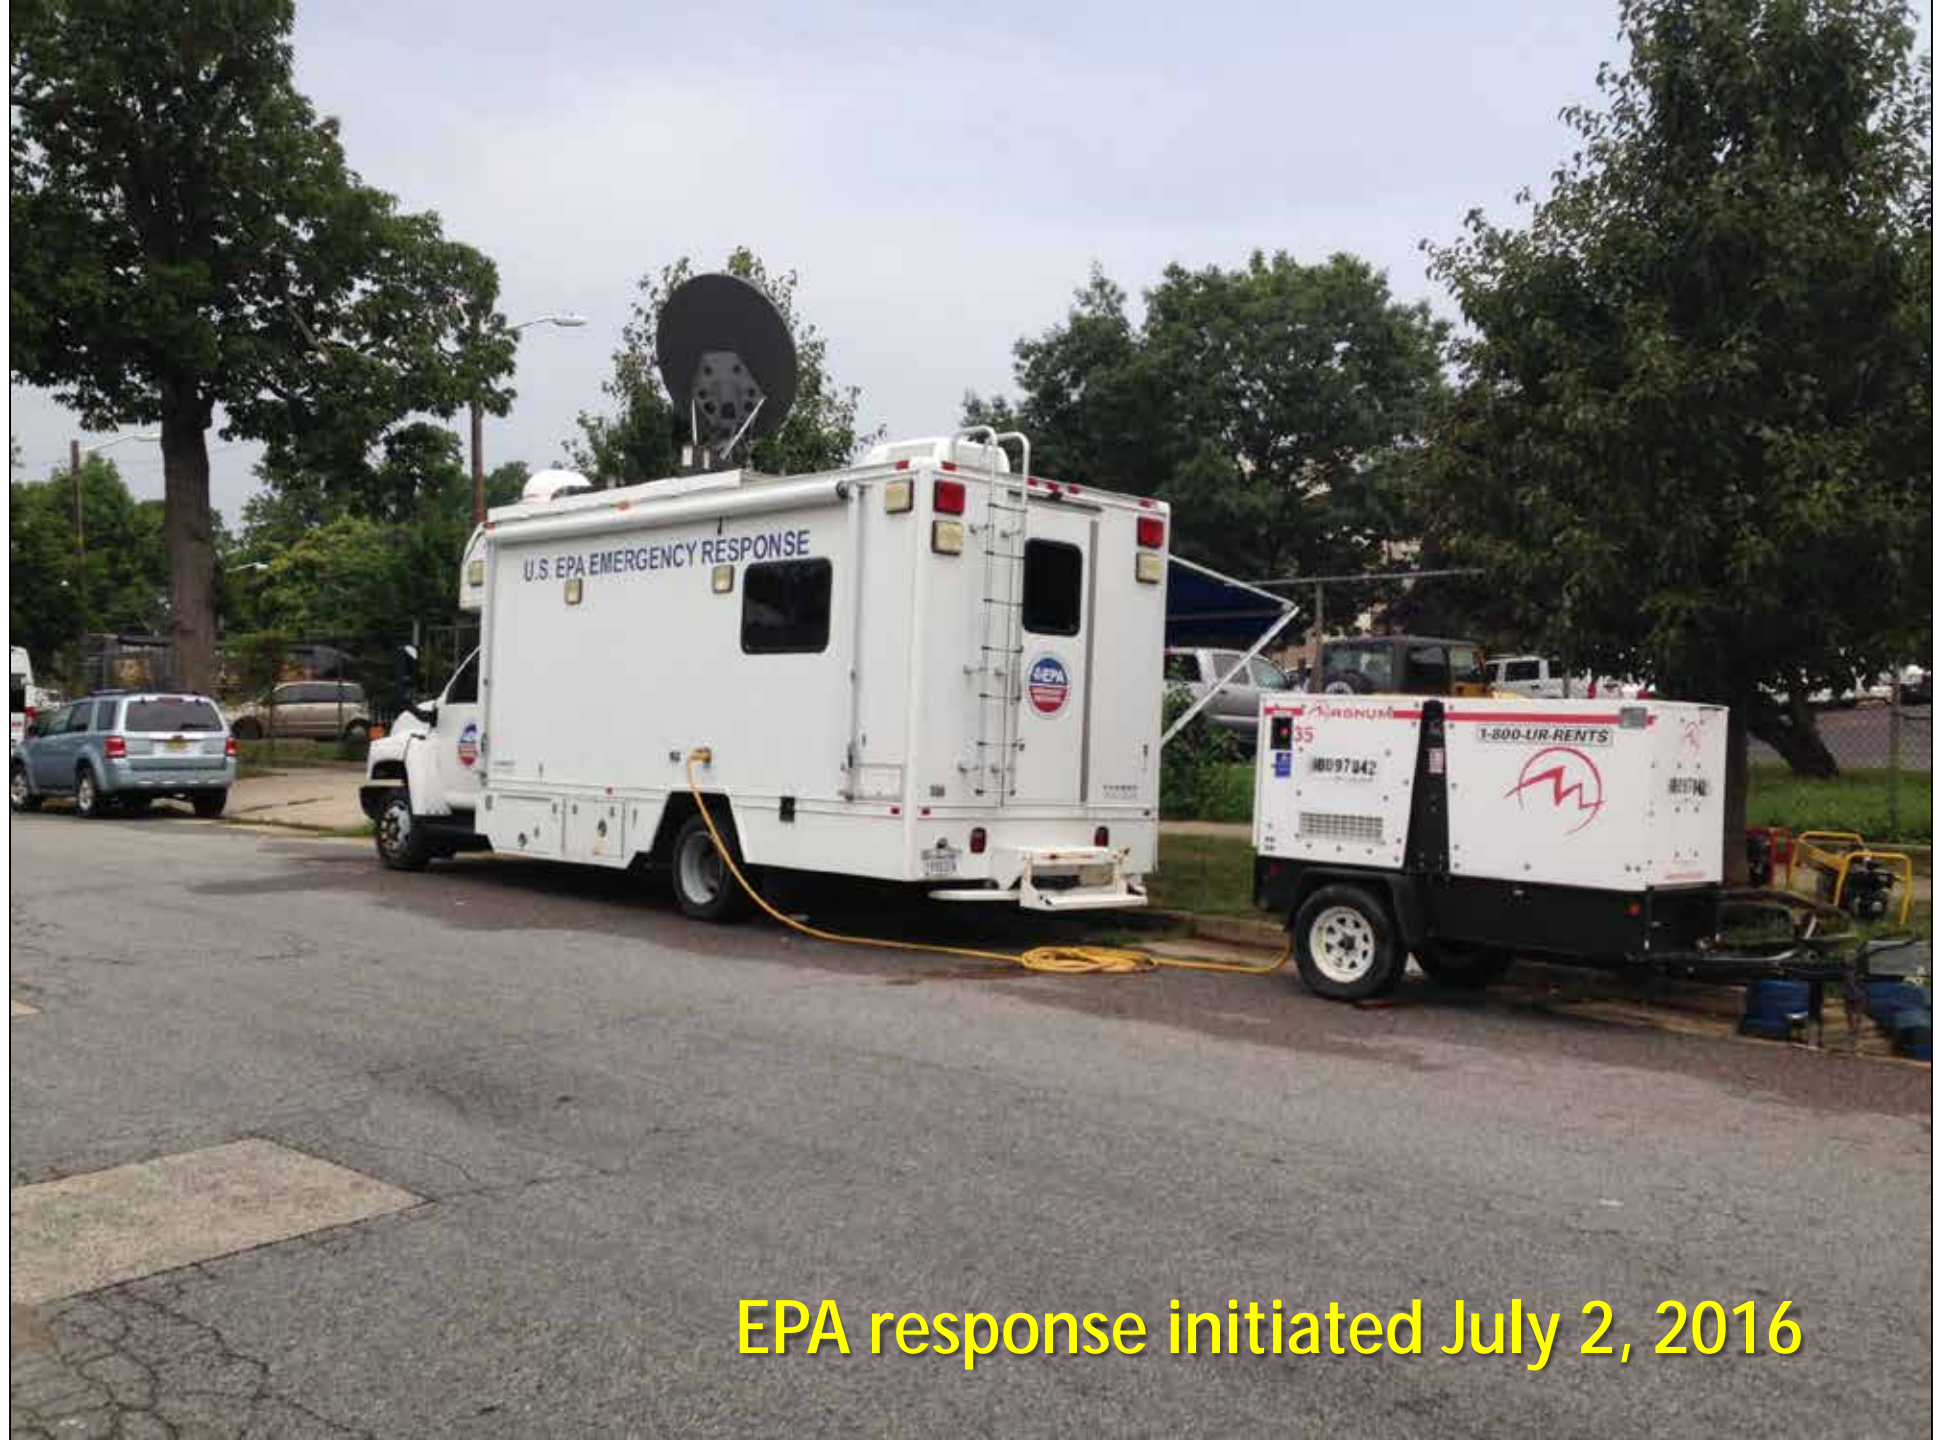
Initial assessment by EPA and facility owner refrigeration engineering contractors identify numerous serious deficiencies in the system and the need to remove the ammonia and repair the system as soon as possible.

Dangerous ice buildup on refrigeration coils – increased load beyond breakpoint

Serious concerns about ice buildup stress on building integrity

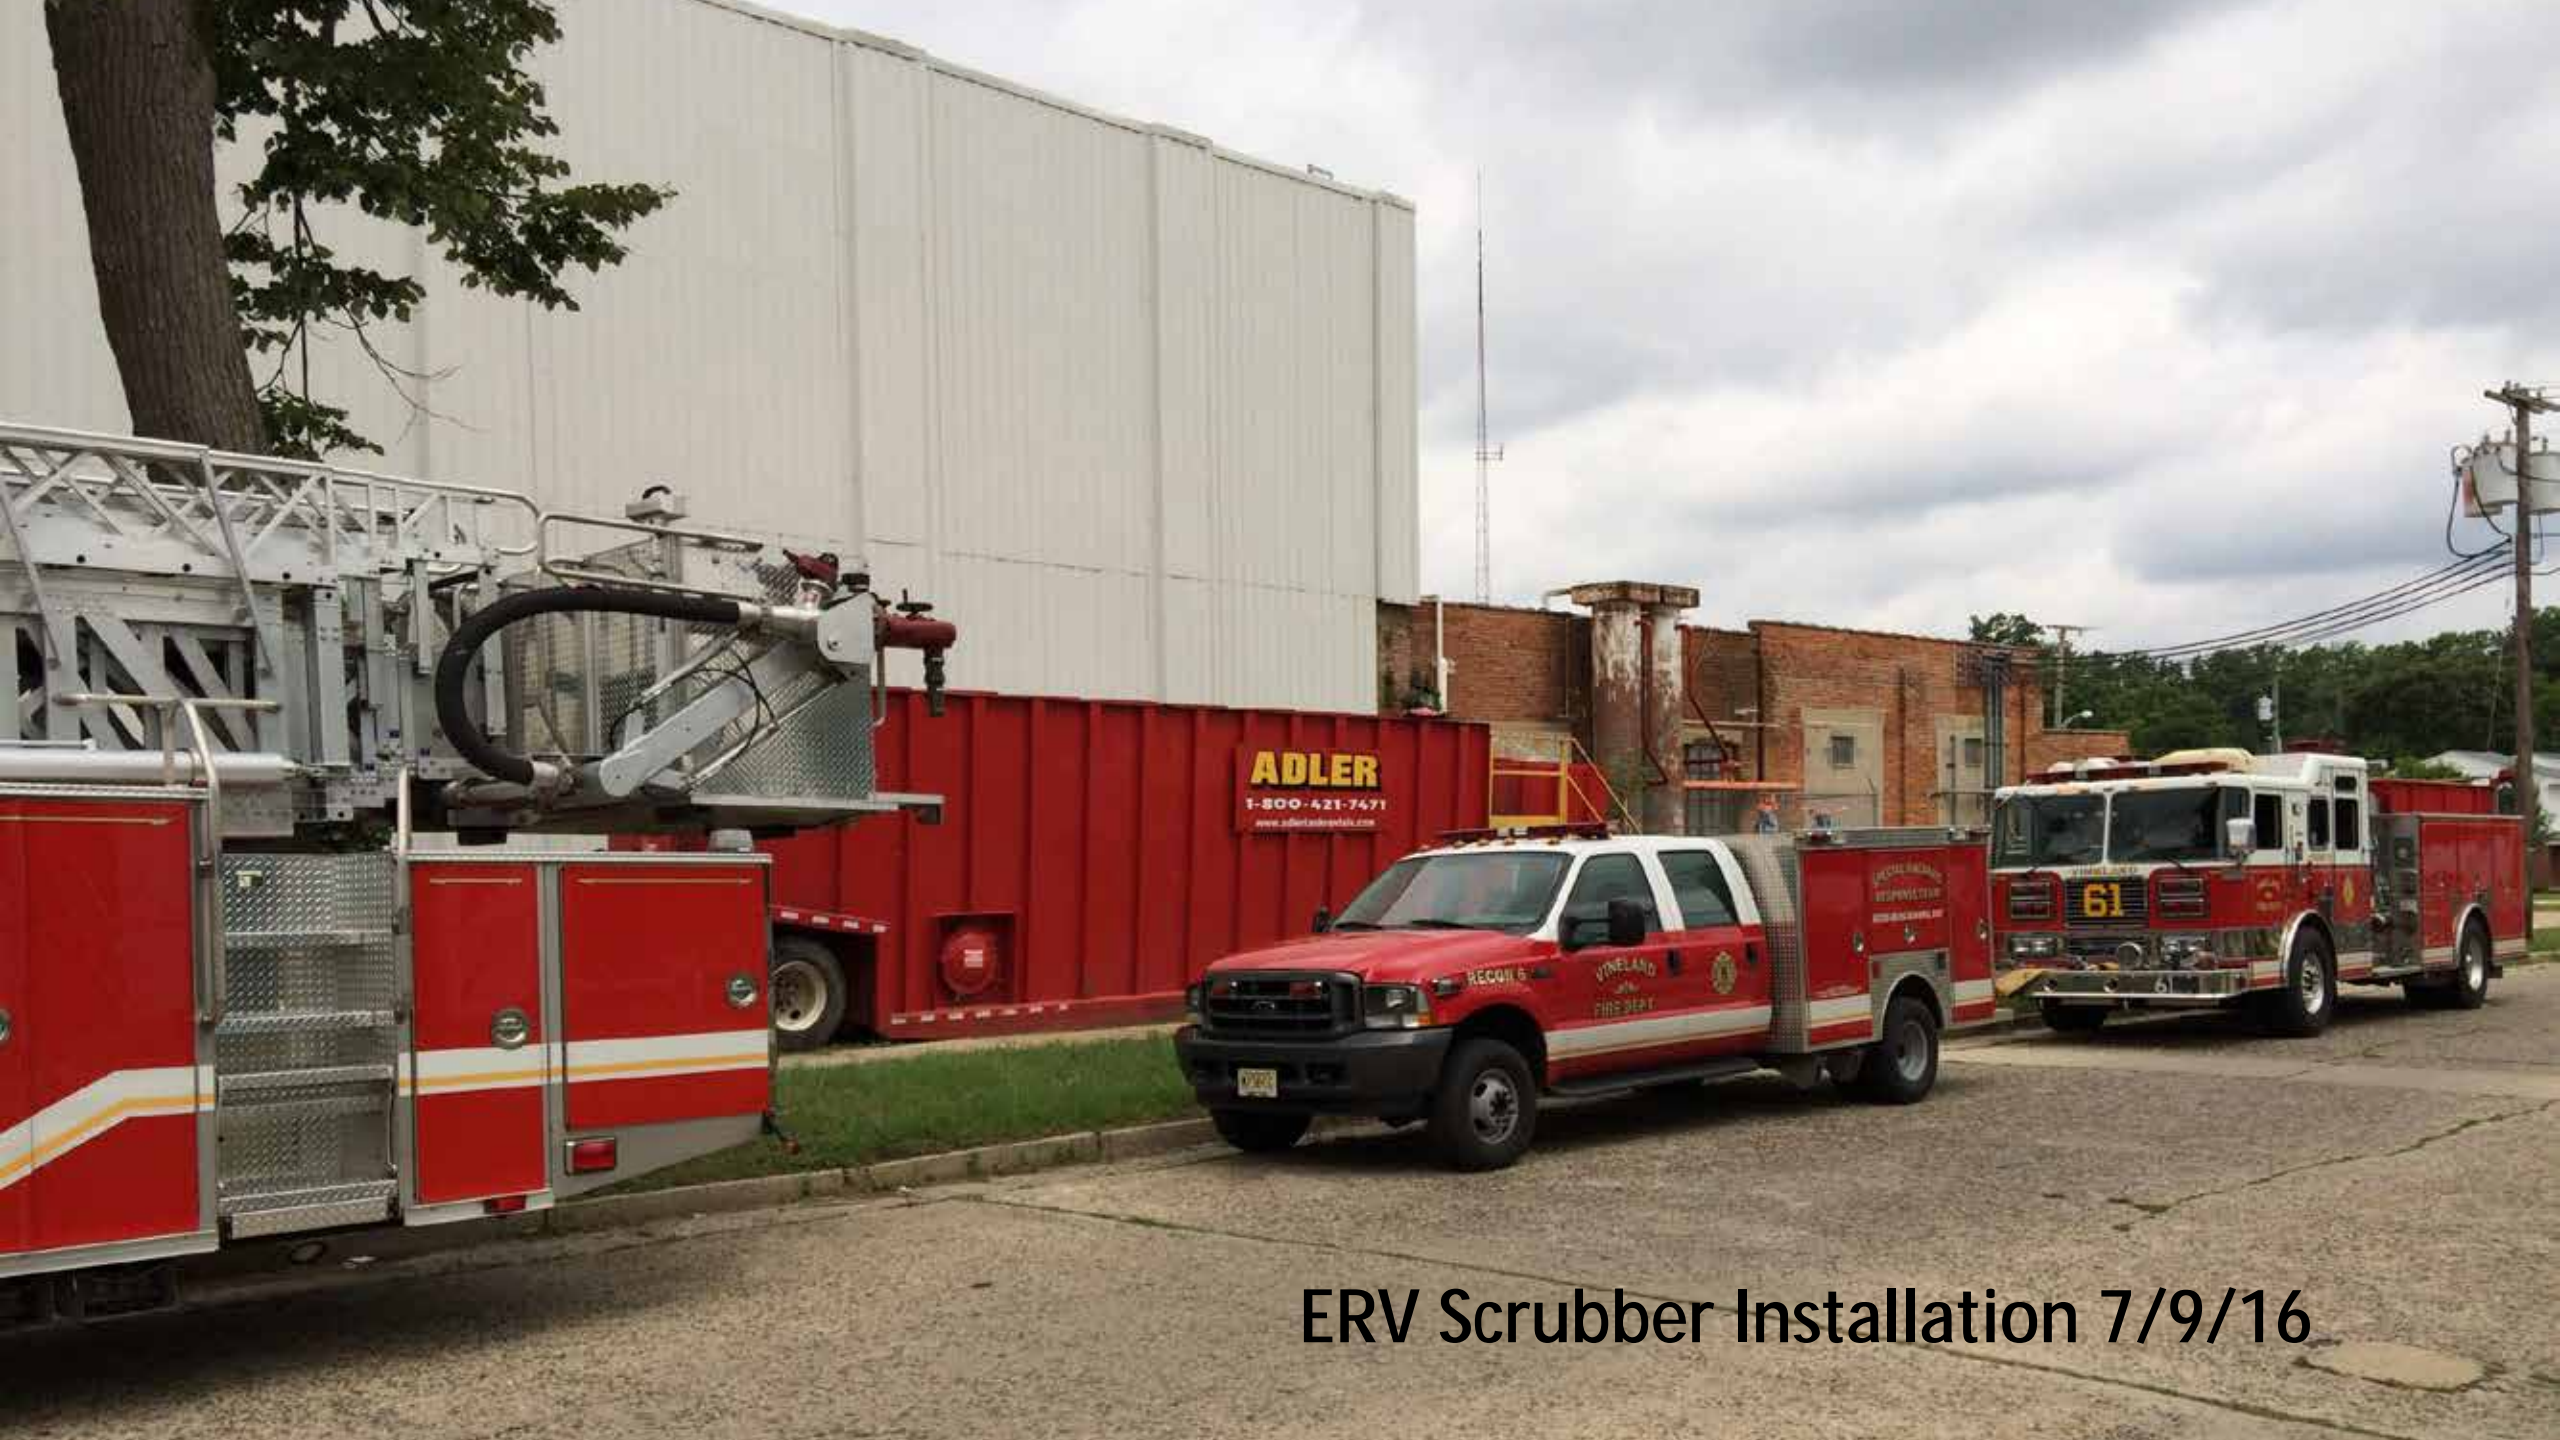
ERV Scrubber Installation 7/9/16

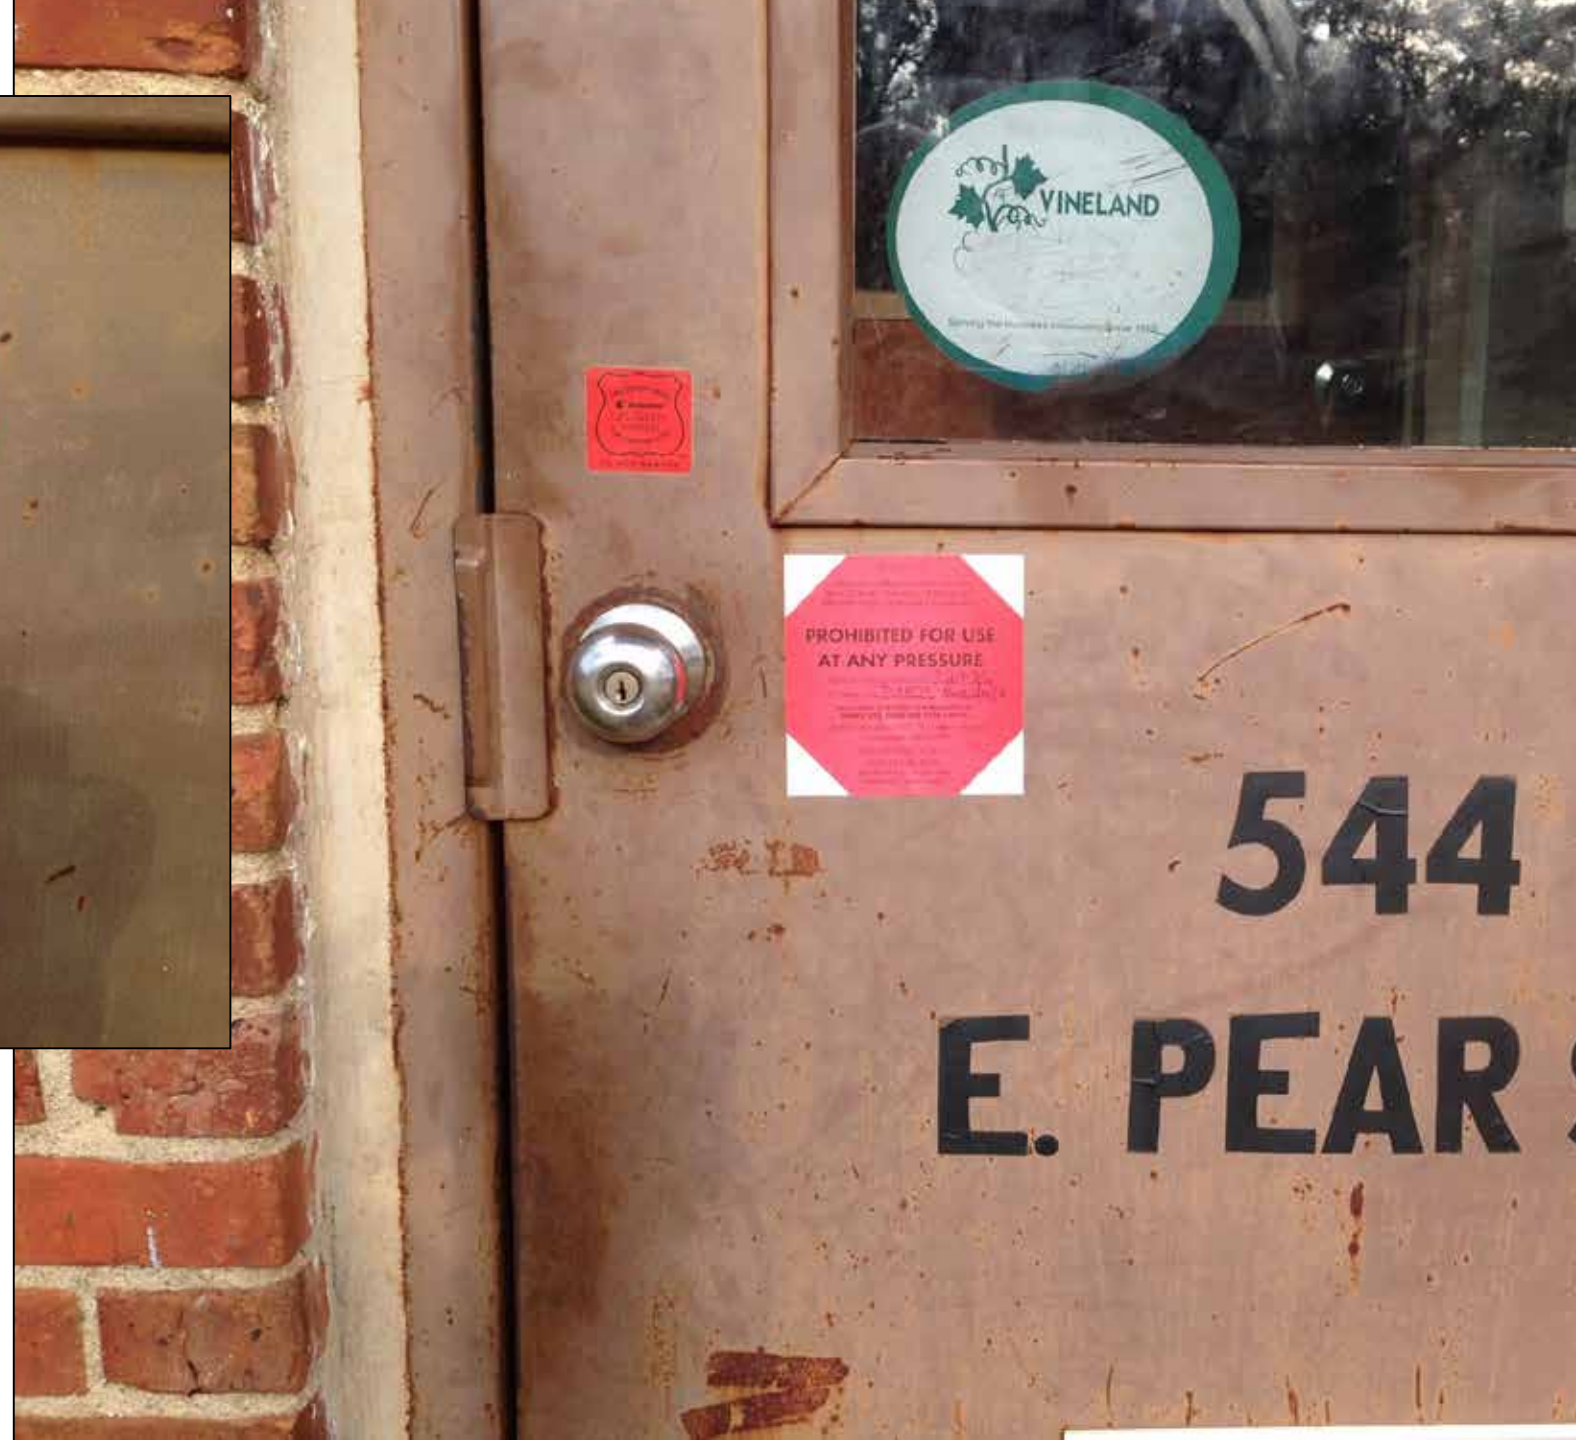
NJDOL Boiler
and Pressure Vessel
Red Tag 7/23/16

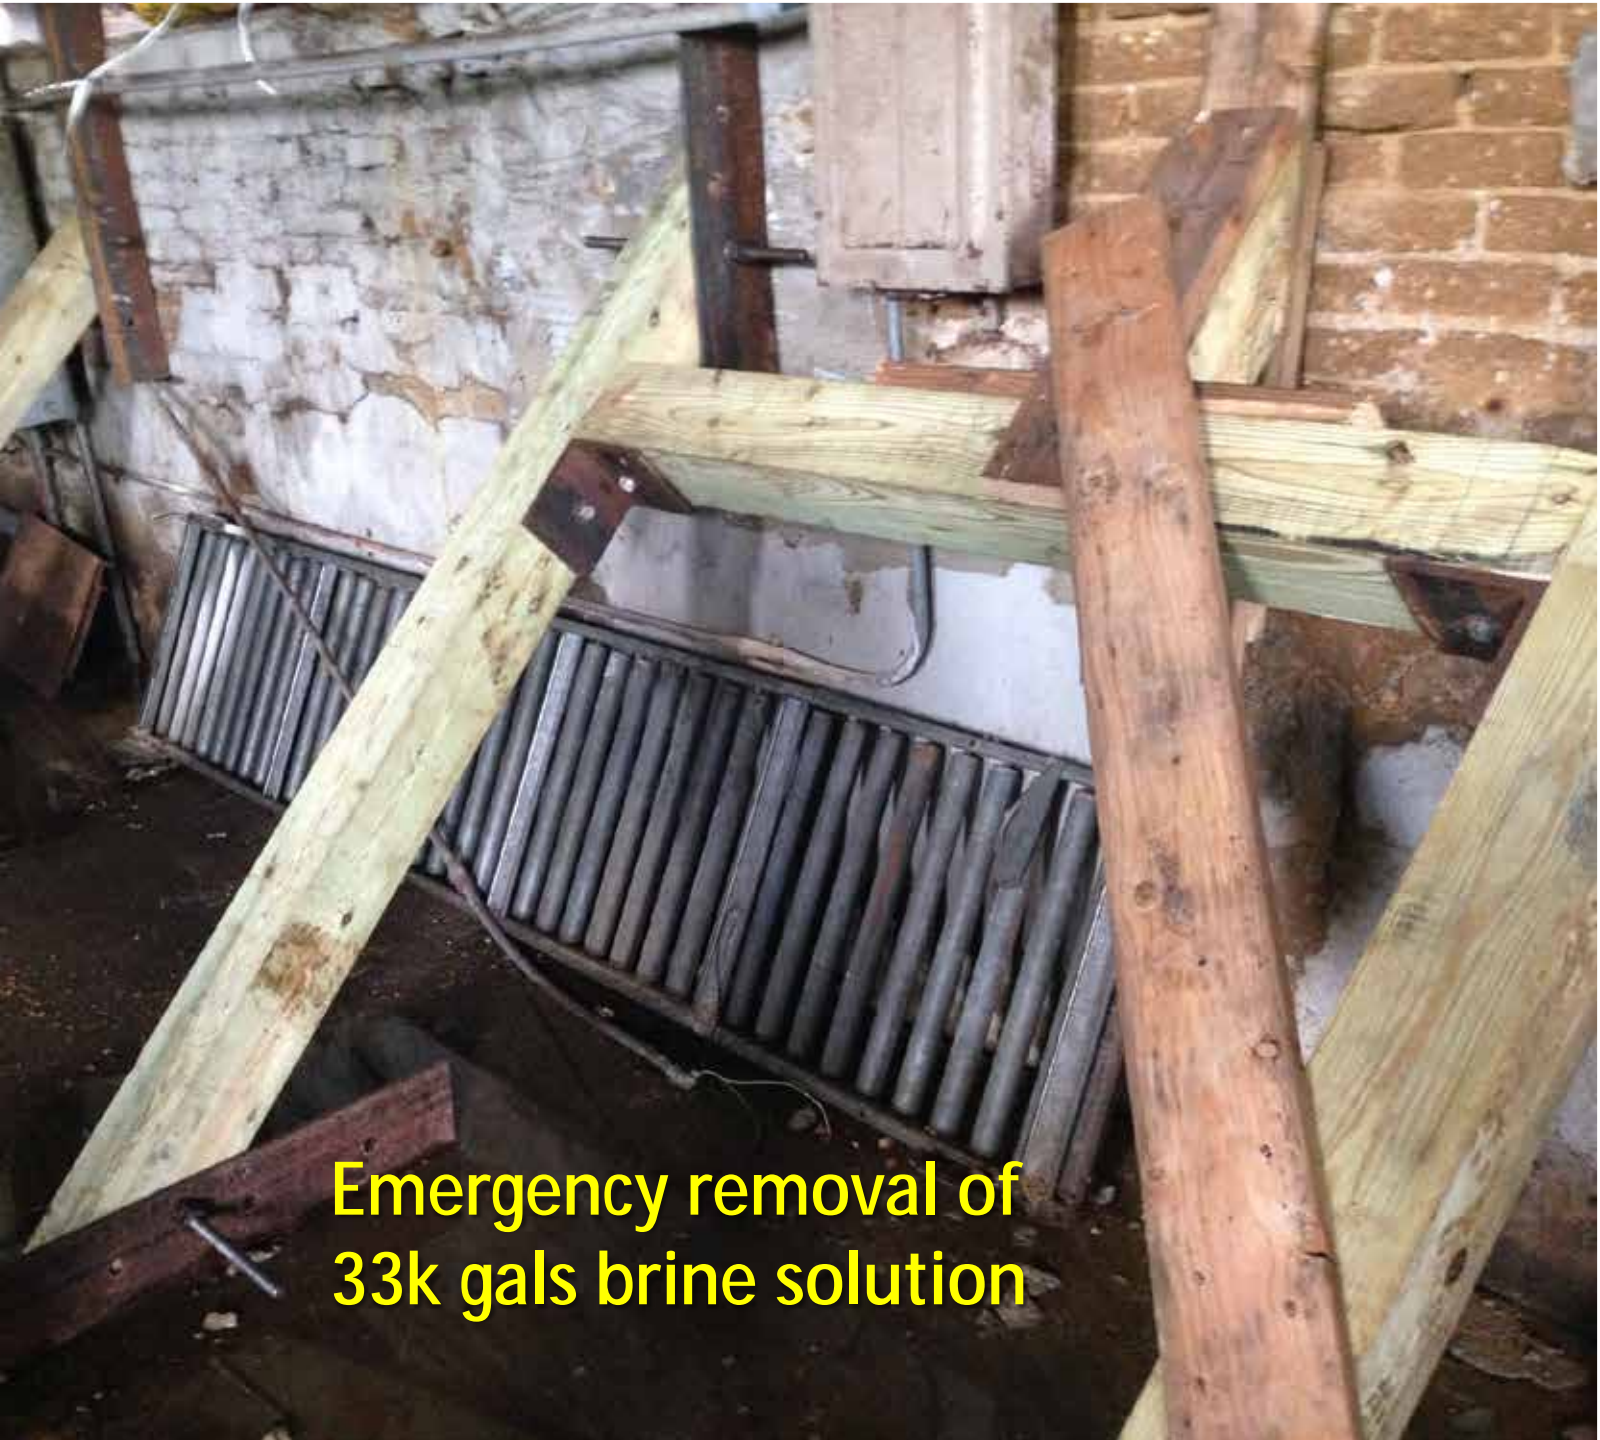
Emergency removal of
33k gals brine solution
