U.S. COAST GUARD CASE
STUDIES:

ATLANTIC STRIKE TEAM

TANK BARGE ARGO

EDWARD J. PRIMEAU, CIH

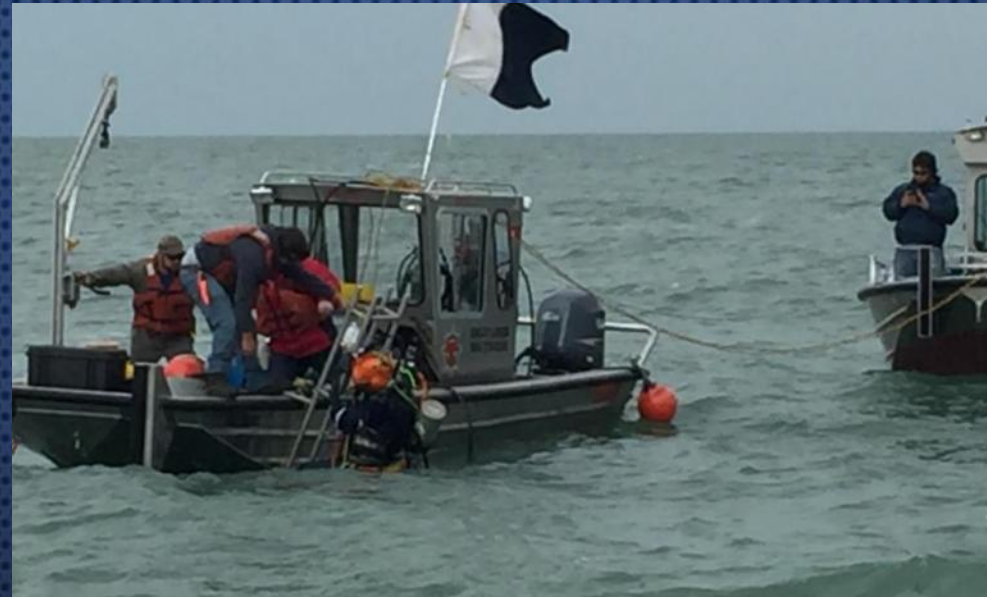
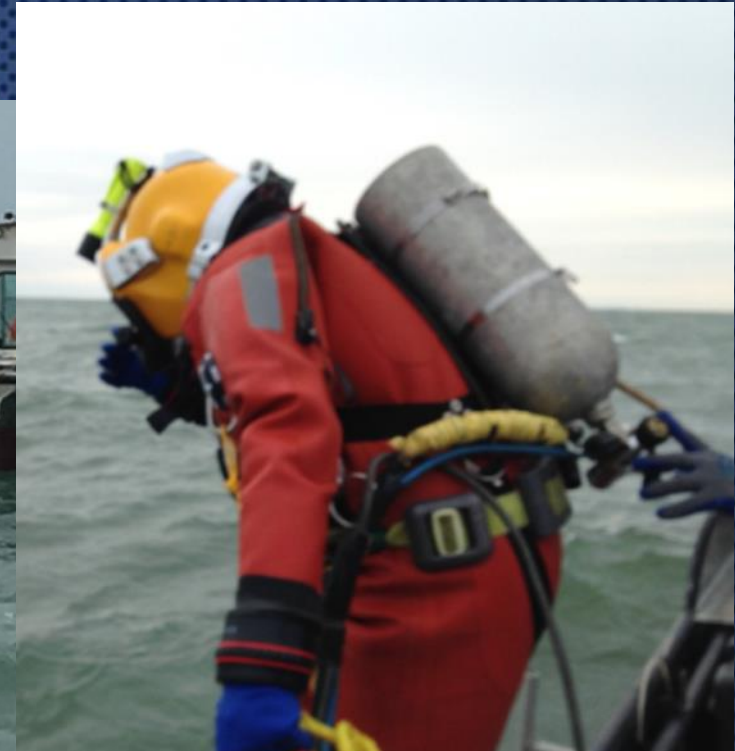
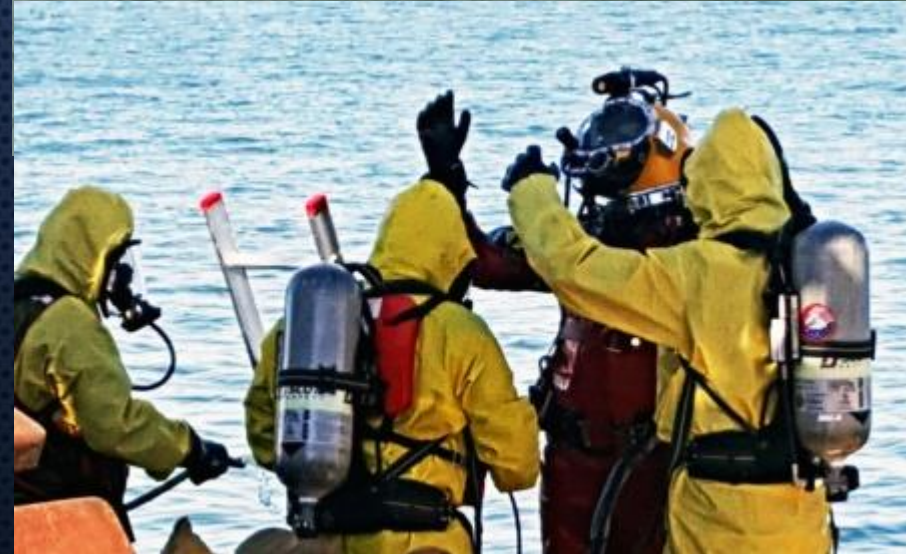
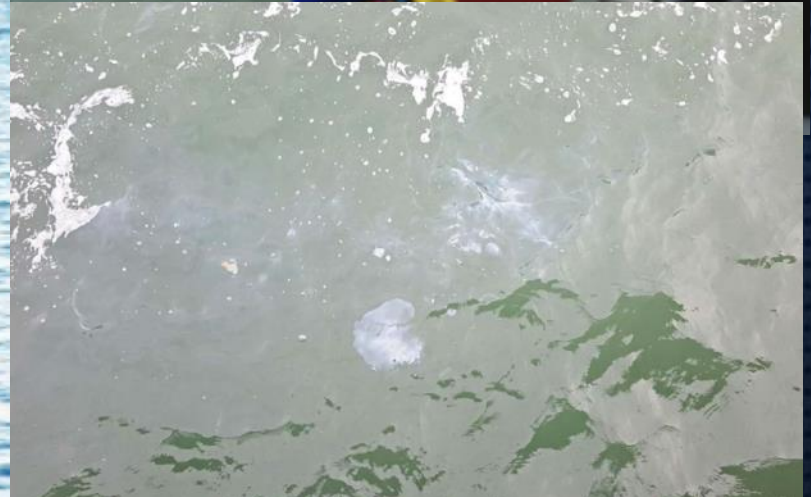
- Matched dimensions
- Heavy marine growth
- Partially buried within sediment
- Periodic sheening originating from barge
- Strong solvent smell

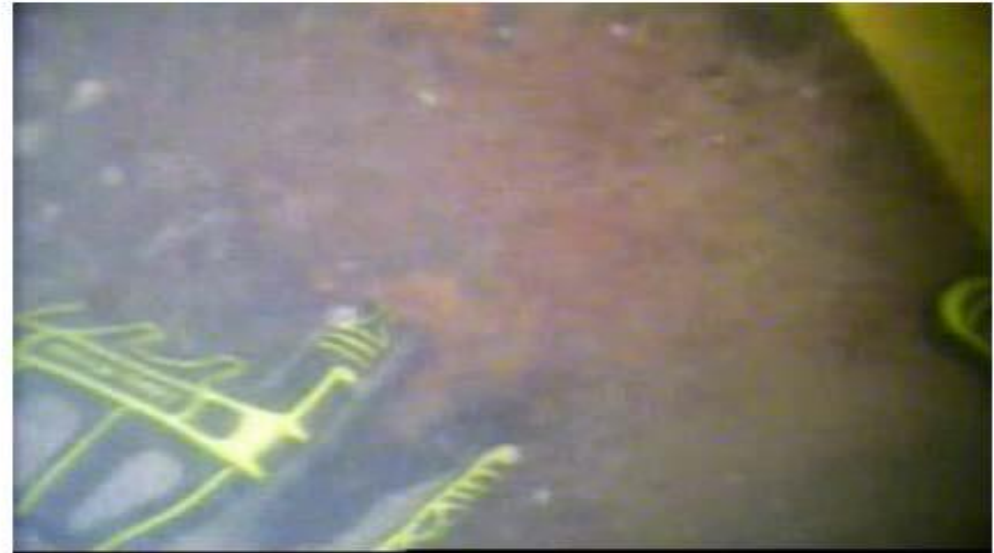
Penetration in Bow Area

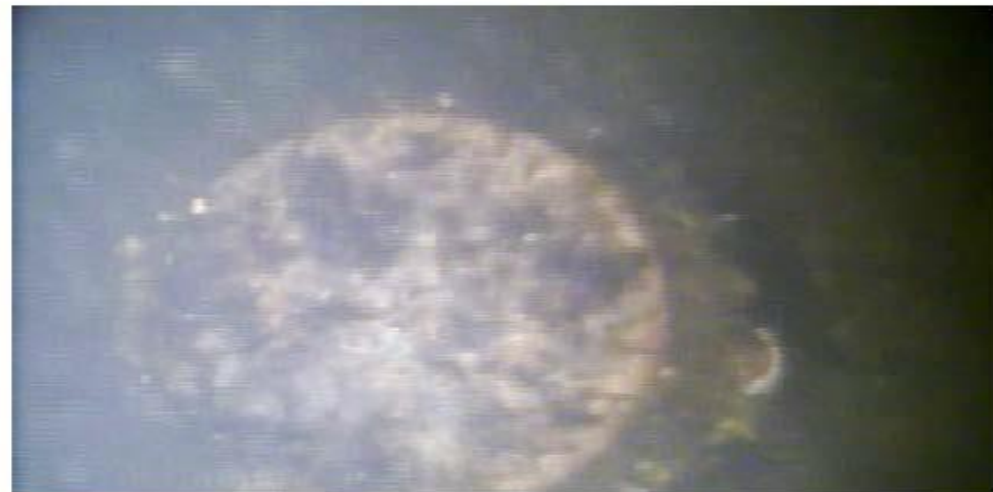
Capped Piping on top of Hatch Cover

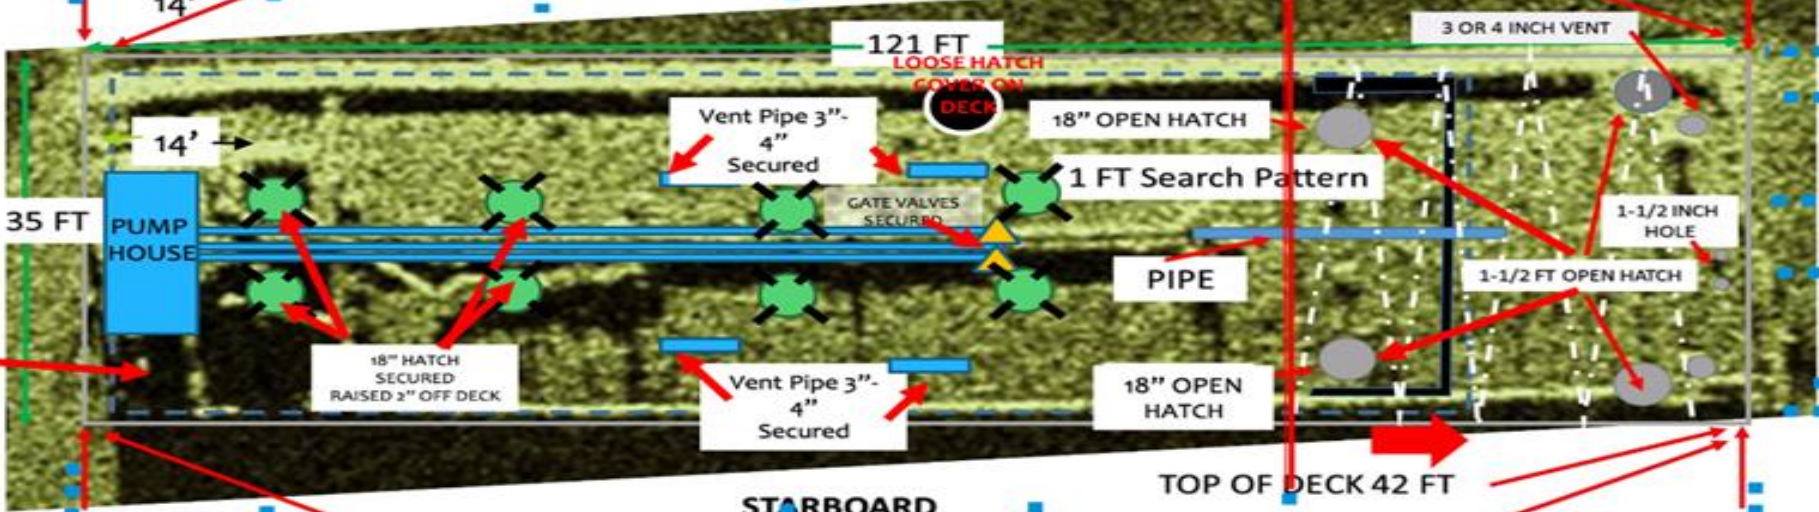
(3) 6"-8" Pipes open covered with marine growth

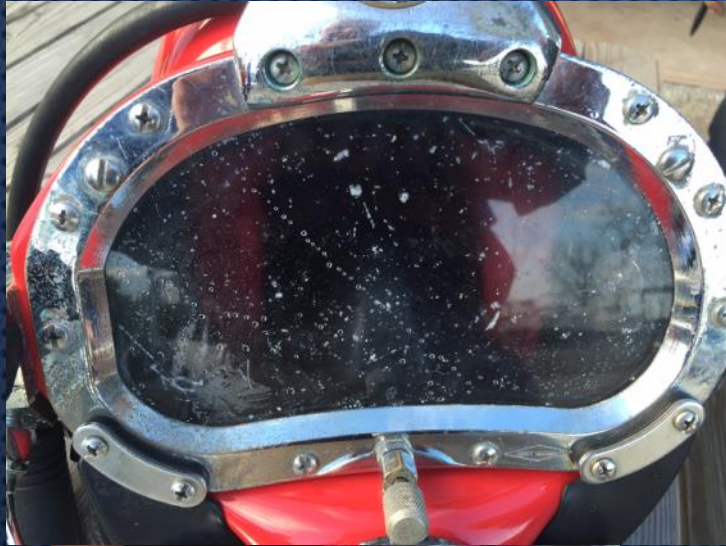
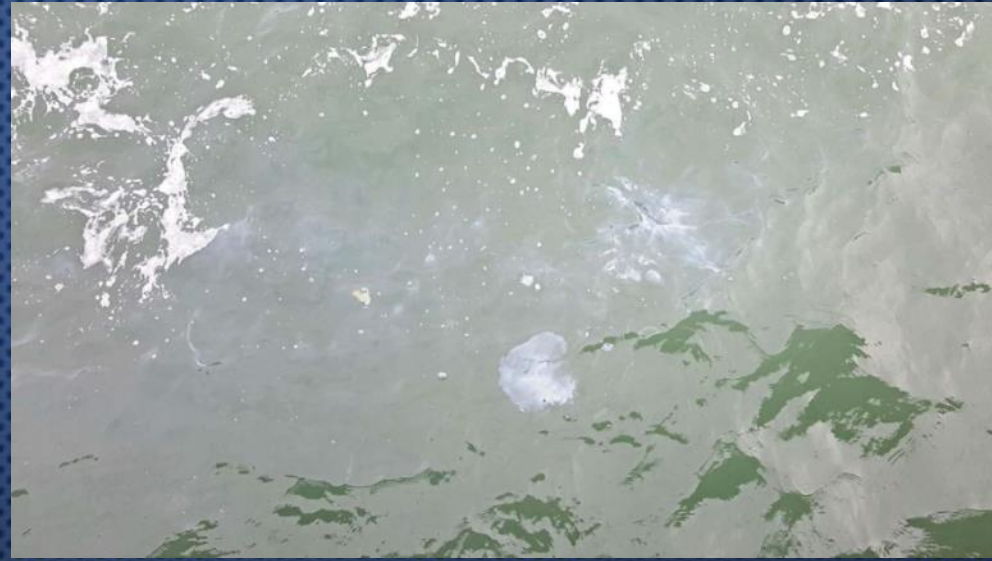
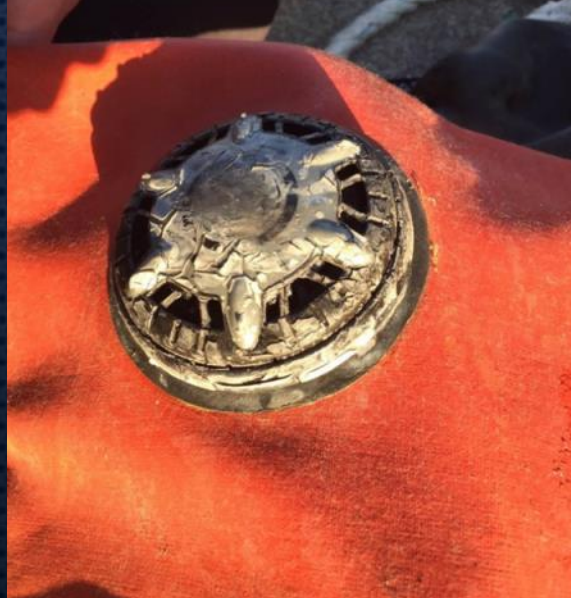
DISCHARGE DURING DIVE OPERATIONS

Discharge during dive operations- 04 NOV

- Rivet came out during hull preparations
- Personnel exposures
- 459 ppm-isobutylene units total VOCs
 - Action Level- 5ppm
- 94 ppm Benzene with the Ultra Rae
 - Action Level- 0.5ppm
- Leak patched; dive suit showed signs of degradation
- Safety stand-down
- Medical evaluation
- Reevaluate the way forward
