Office of Pipeline Safety

Pipeline and Hazardous Materials Safety Administration

Overview

RRT 2
November 8-9, 2023
Sayreville, NJ

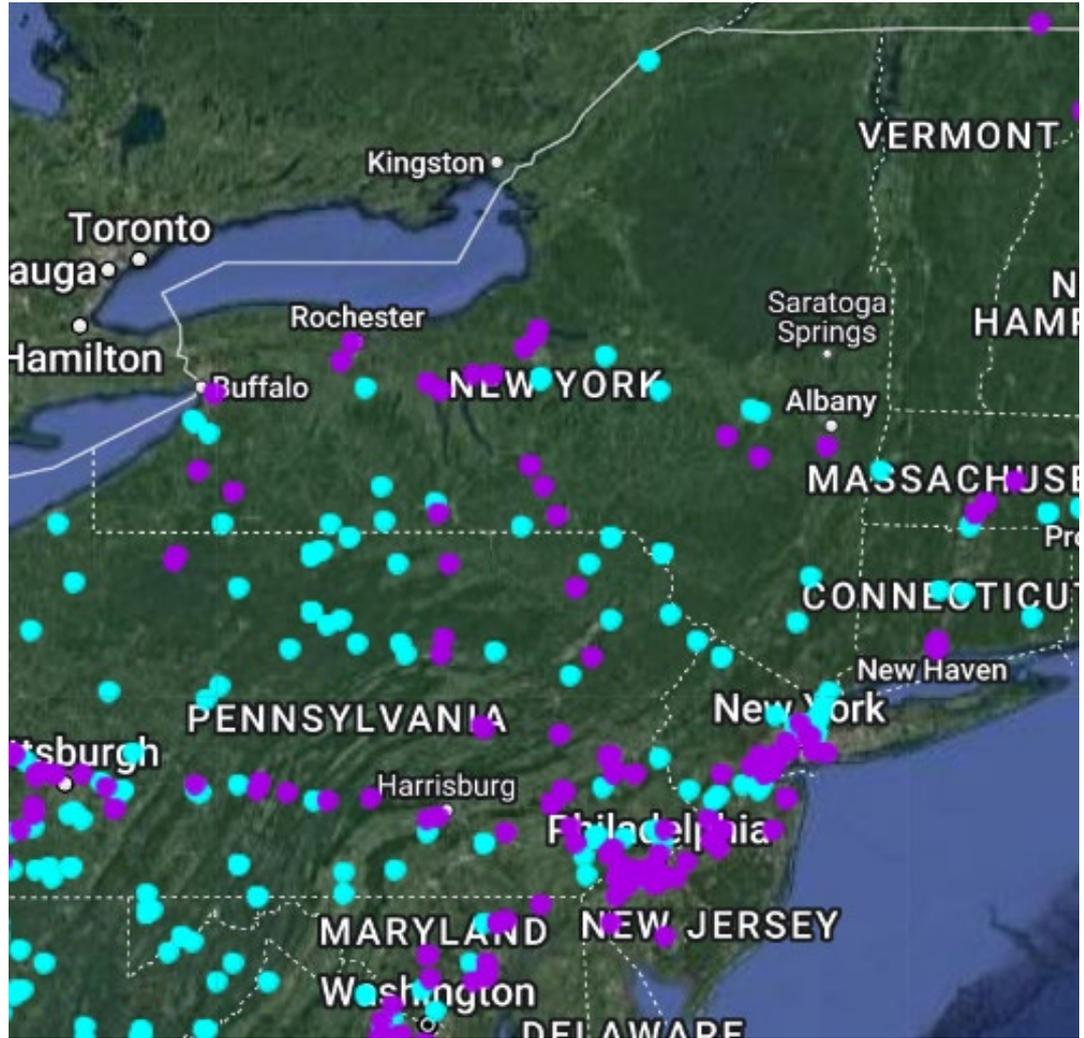
RRT 2 Release Map

Teal = Gas Incidents

Purple = Liquid Accidents

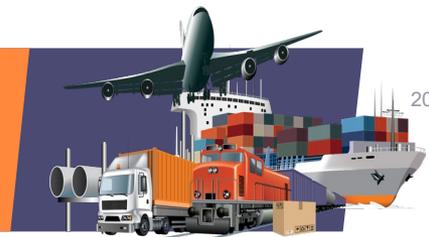
Root Cause & Lessons Learned

- Incorrect Operation - Failure to Follow

Procedures:

- Pressure not relieved, gauges not monitored, insufficient pressure gauges, LOTO not observed
- Did not notify supervisor when ice encountered
- Technician was positioned in front of the open pig trap

- Operator failed to address the leaks in the system allowing hydrates to form

- Blow off stacks and 1-inch blowdown were relieving
- 10-inch isolation valve was leaking
- Pig signals were not functioning
- 10-inch East line has history of low flow, hydrates, and leaking interconnects
- Ice commonly forms in the line
- Technicians did not perform LOTO prior to this task
- No work permit had been issued to perform this task

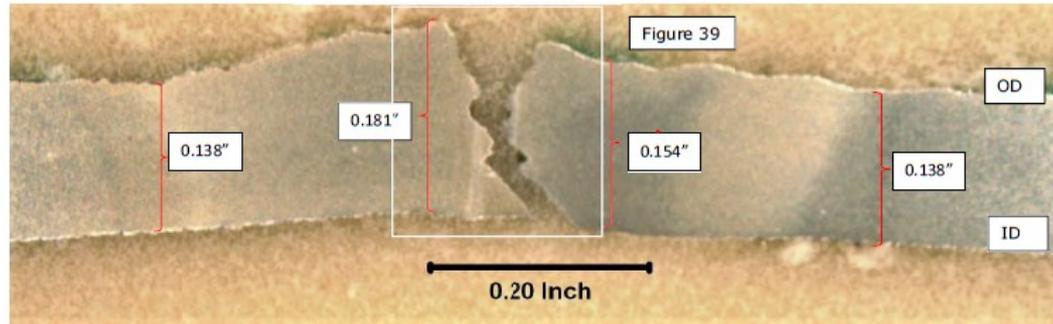
Investigation Findings

- Magellan ran two ILI's using a T.D. Williamson (TDW) tool.
 - 2015 run revealed three 10% metal loss features on the ruptured joint. One of these was at the same location as the SSWC rupture
 - Integrity Management regulations call for long seam corrosion to be investigated within 180 days of the ILI run. Magellan failed to investigate timely.
 - 2020 run data had not yet been compiled and was still under analysis by TDW at the time of the release. Magellan requested accelerated review of this section of the pipeline.

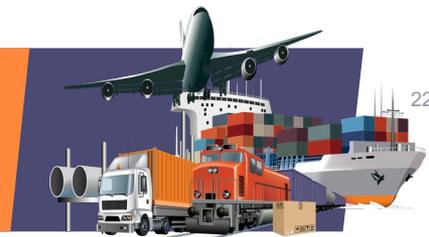
Investigation Findings

- Tape coatings are known to commonly dis-bond from the pipe and shield against cathodic protection
- Analysis of the pipe section by DNV indicated SSWC. Corrosion developed under the tape and accelerated the weakening of the pipe wall until it was compromised by the hoop stress caused by the pipeline's internal pressure
- Effects of welding the long seam include creating a different metallurgical structure around the weld than the pipe "plate" material. When under the influence of corrosion various structures may become anodic to the rest of the pipe and accelerate corrosion.

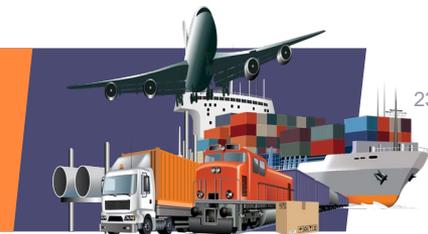
Root Cause & Lessons Learned

- SSWC, which ruptured the ERW long seam
- Spill exacerbated by SCADA operator, increasing volume
- Original coating damaged and repaired with a tape coating known to be prone to failure, accelerated corrosion
- 2020 ILI data demonstrated a defect, but the analysis of that data did not occur prior to the rupture

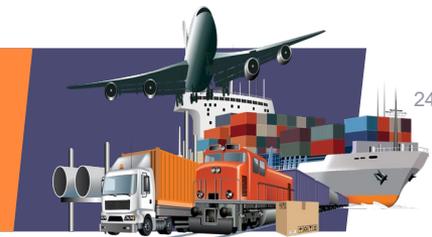
Investigation Findings – Tennessee Gas 6/2021

- West Bloomfield, NY
- Rupture in the body of the pipe (not in a seam)
- A.O. Smith pipe in the 1950's has history of failure
- ILI tool found no indications of hard spots
- Location was at the bottom of a hill (at a bend)
- Suspect hard spot in a wrinkle bend
- Land/seismic movement suspected

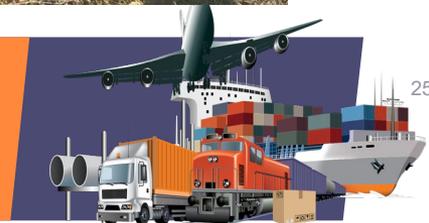
Root Cause & Lessons Learned

- LiDAR indicated no land movement
- ILI tool specifications were not sufficient to identify a wrinkle/buckle
- Unknown source of stress
