# Proposed Designation Mallows Bay, Expansion of USS Monitor NMS and

An Update on NOAA's Remediation of Underwater Legacy Environmental Threats (RULET) Database

NOAA Office of National Marine Sanctuaries
Lisa Symons

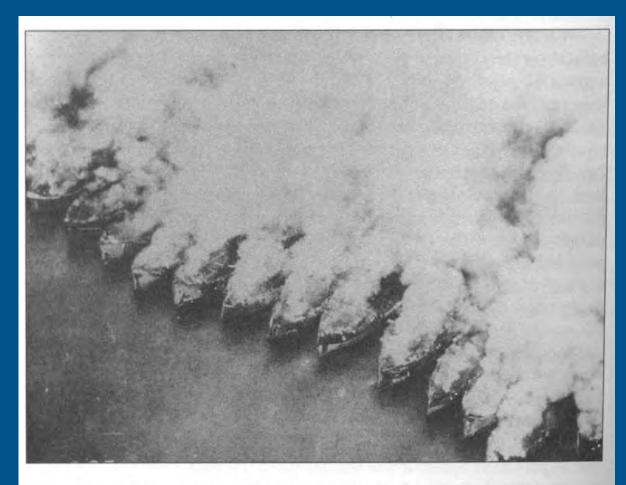
#### November 7, 1925

Thirty-one wooden U.S. Shipping Board steamers go up in smoke on November 7, 1925, the greatest destruction of shipping at one time in the history of the Potomac River. Courtesy National Archives and Record Service

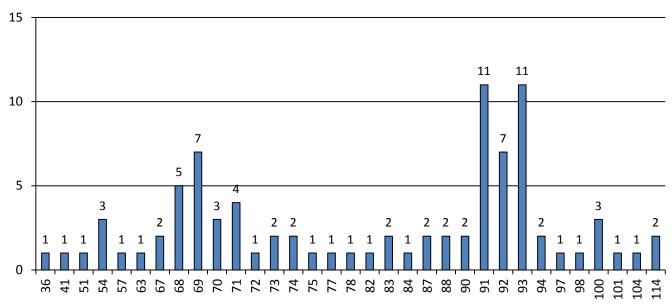
#### **Current Age (yrs) of Shipwrecks**

Age of Vessel in 2012

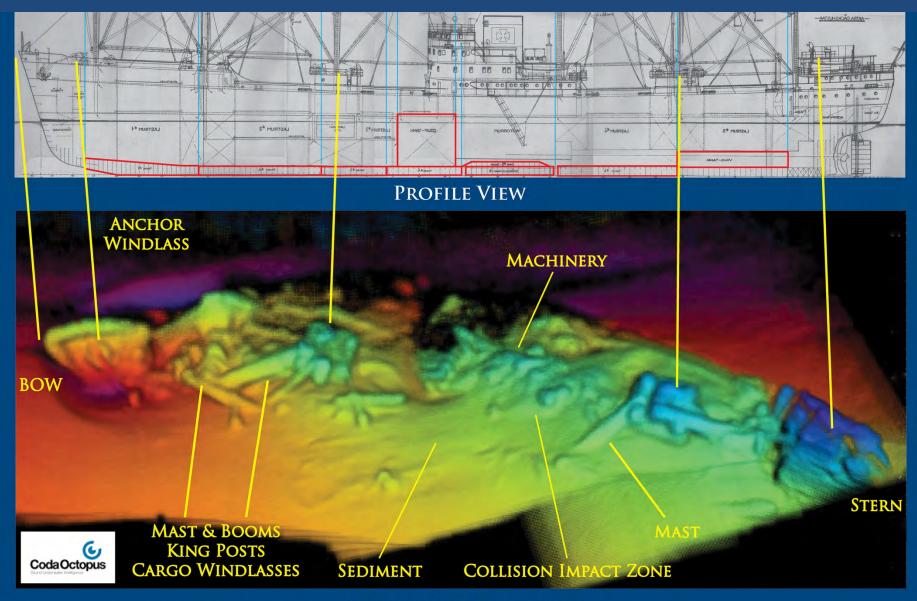
### **FERNSTREAM**

DOWNWARD DECK VIEW

Vessel Assessments	Dat	Status	WCD	MP
	е			
*Fernstream, SF CA	3/14	WCD down, MP same following survey, monitoring		
**W.E Hutton, NC	8/14	Found due to sheening, correctly identified, plugged, monitoring		
*USNS Mission San Miguel, HI	8/15	Found assessed, scores reduced from H/M		
Coimbra, LI NY	8/15	Satellite detection of sheening, no shoreline impact		
*USS Murphy, LI NY	8/15	Found due to sheening, similar to <i>Coimbra</i> , not yet scored		
<i>Argo</i> , OH	9/15	Assessment and recovery fall 2015. Now Low/Low after removal.		
Coast Trader	6/16	ROV survey of opportunity, recent side scan – substantially intact	*	*

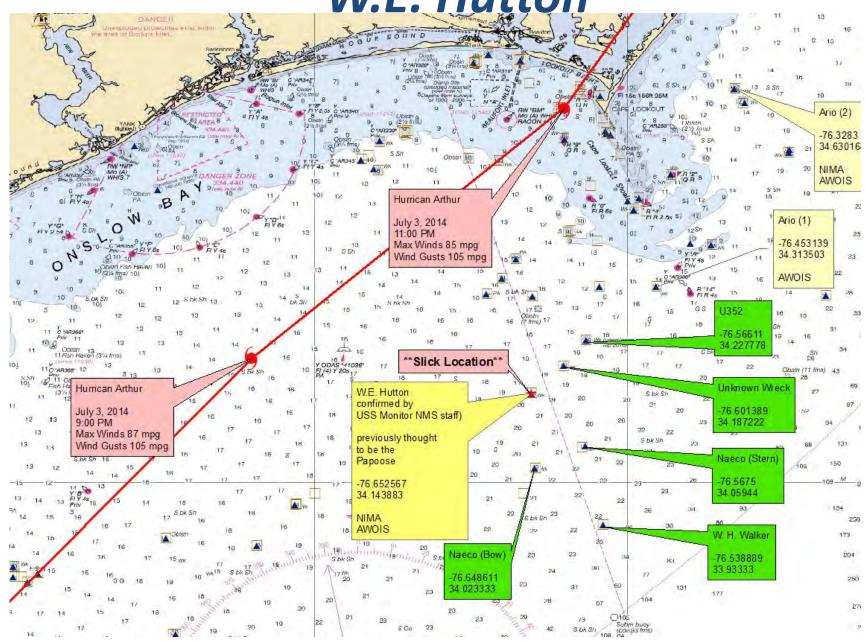
W.E. Hutton

- Excluded from RULET based on NOAA video footage showing all tanks open to the sea. Later determined to be wire dragged tanker *Ario*.
- The wreck formerly identified as *Papoose*, now known to be *W.E HUTTON*. 453 ft tanker carrying 65,000 barrels of #2 heating oil plus bunkers, torpedoed by a German U-Boat and sank on 18 March 1942. ~125 feet deep, upside down, port side buried
- W.E. Hutton, Papoose and Ario are all in the same general vicinity.

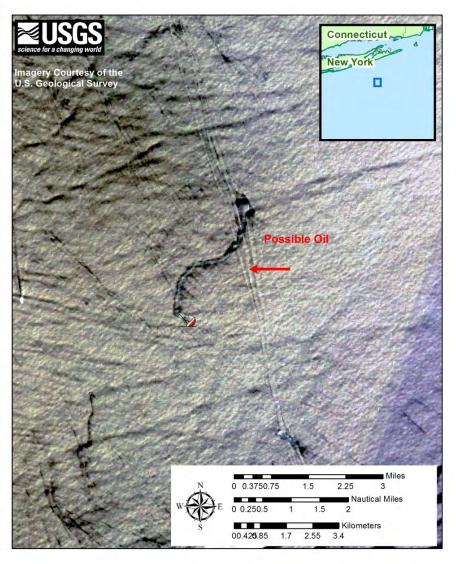
Torpedoed Tanker Coimbra : [ 40°24'01" N / 72°22'12" W ]

An oil slick was detected emanating from the torpedoed tanker Coimbra approximately 53 miles southwest of Montauk Point. The slick was 2.9 miles in length and up to 0.3 miles wide. Skies were clear and winds were from the southeast at 5 knots at the time of the image.

Confidence is high that the slick is oil because the Coimbra is a known repeat leak source and portions of the slick appear shimmery in the high resolution imagery.

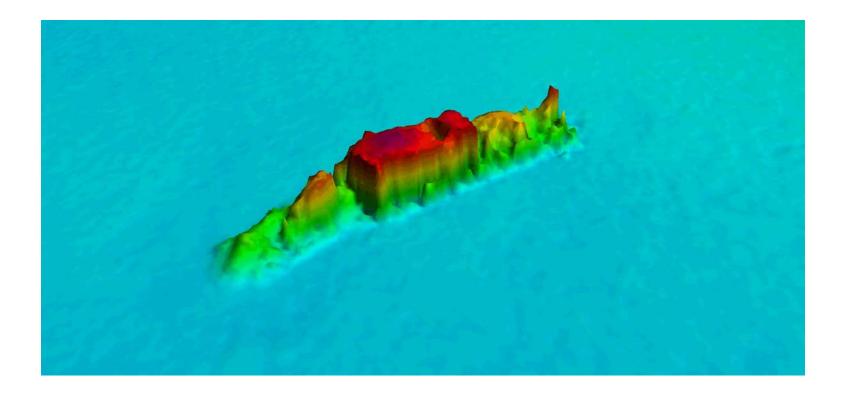
#### **Coast Trader**

Recently found in Canadian waters
ROV based survey of opportunity June 1st 2016
Looks more intact than expected, score could change
