U.S. COAST GUARD CASE
STUDIES:

ATLANTIC STRIKE TEAM

TANK BARGE ARGO

EDWARD J. PRIMEAU, CIH

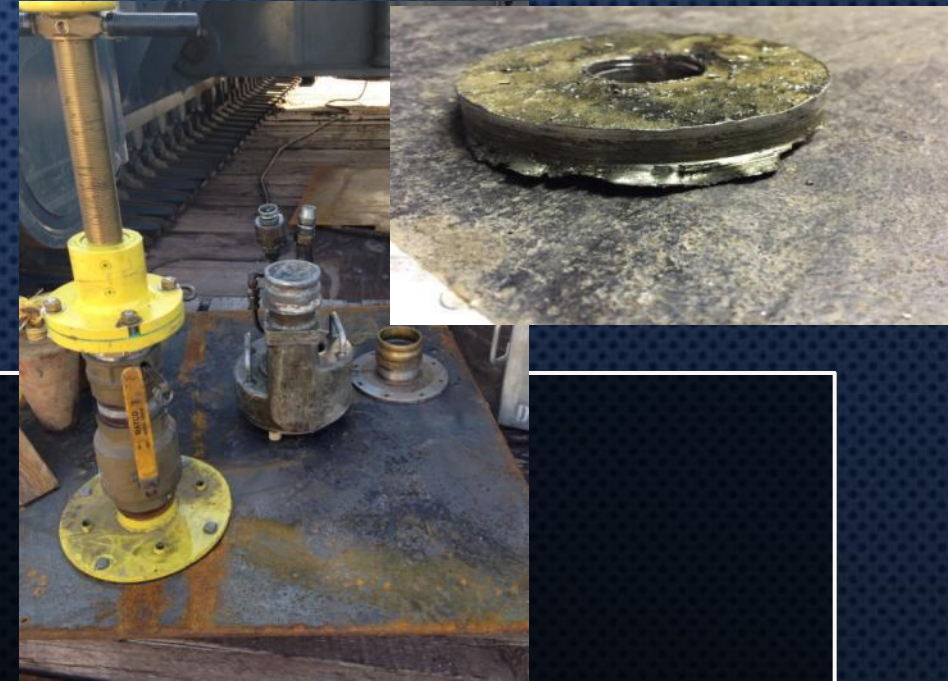
Hot Tap and Lighter from Tank Top

- Minimal hull disruption
 - Non destructive tests
- Reduced potential for rivet failure & discharge
- Required no excavation of sediment

Logistical challenges

- Weather / Sea state
- Temporary Storage
- Winter / Ice approaching

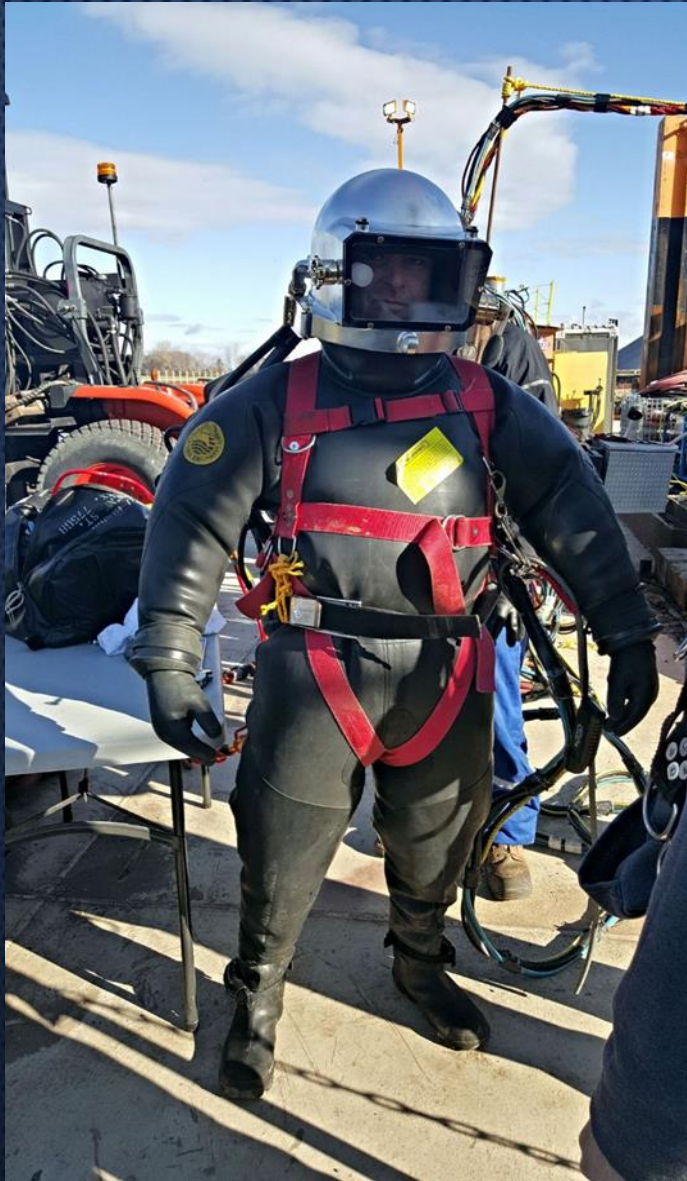
Sampling and Characterization- 09 NOV

- Upgraded dive suit
- Sample drawn from rivet hole
- Volatile Analysis
 - Benzene – 79.2%
 - Toluene – 17.2%
 - Ethylbenzene – 0.16%
 - Meta & para Xylenes – 2.56%
 - Ortho Xylenes – 0.71%

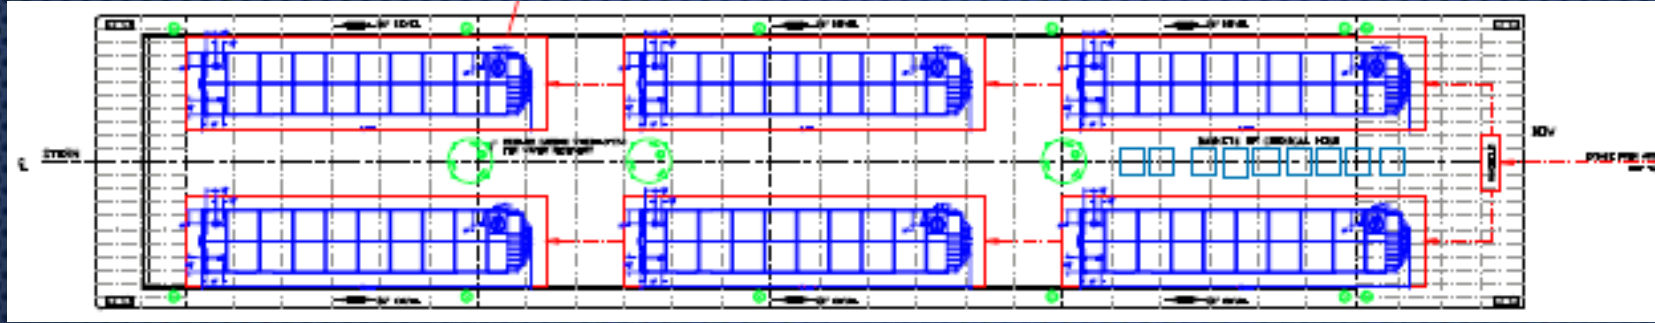
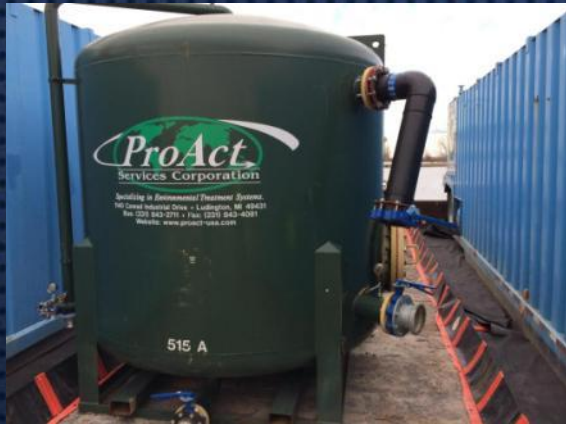
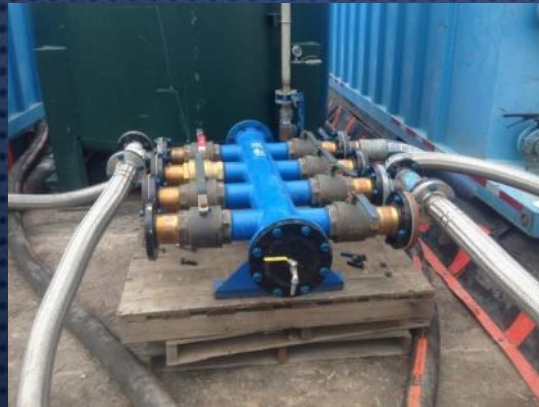
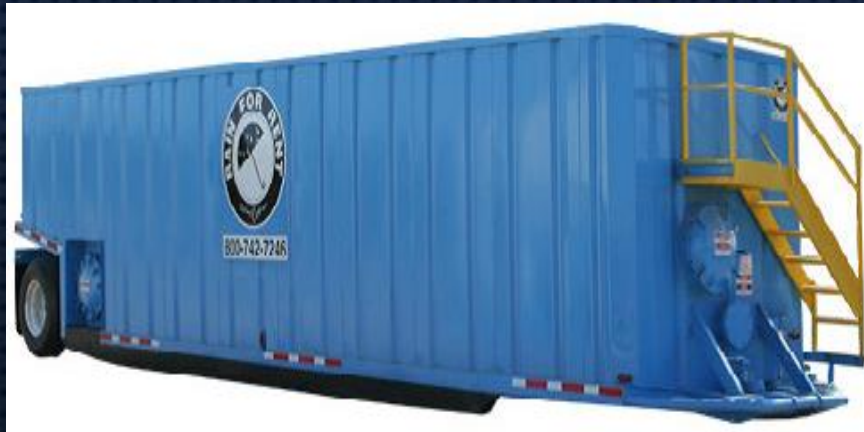
No barges on Great Lakes suitable for product

- Built temporary storage system on deck barge
 - FRAC tanks
 - Vapor Control System
- Naval Architect and Chemical Engineer reviewed each component of system for compatibility
