### Con Edison Dielectric Fluid Spill Prevention, Detection & Response Best Practices

### Joint RRT 1 & 2 Meeting

Vernon Schaefer, Brian DeShong April 12, 2017

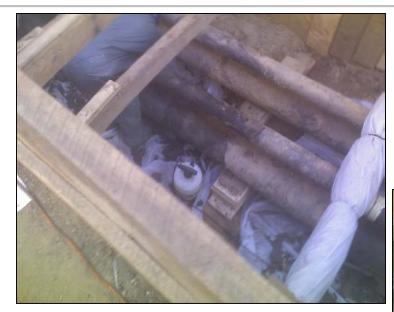
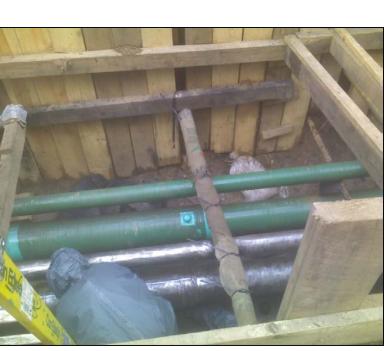
### **Coating Removal and Inspection**

- Feeders M51, M52 are the worst performers in terms of leaks
- Areas to be addressed are selected based on study of historic leak locations, pipe-to-soil potentials, and keyhole inspections
- Selected areas are excavated, stripped of coating (ACM), inspected, permanently repaired (welded sleeves), new coating applied, and street fully restored

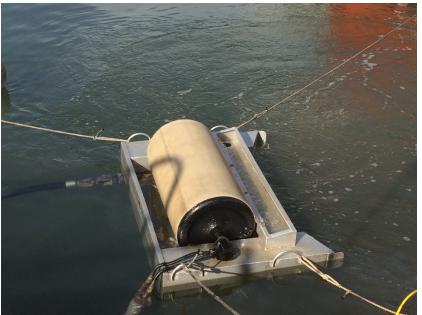
Skimmer in Newport Marina in Jersey City, NJ

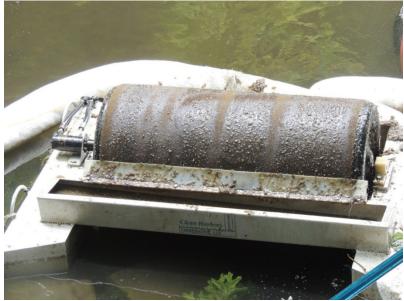
## Skimmer on Bronx River in Yonkers, NY
