South Jersey Ice and Cold Storage
Vineland, Cumberland County, NJ

EPA Emergency Response
June – August 2016

USEPA Region 2
Response and Prevention Branch

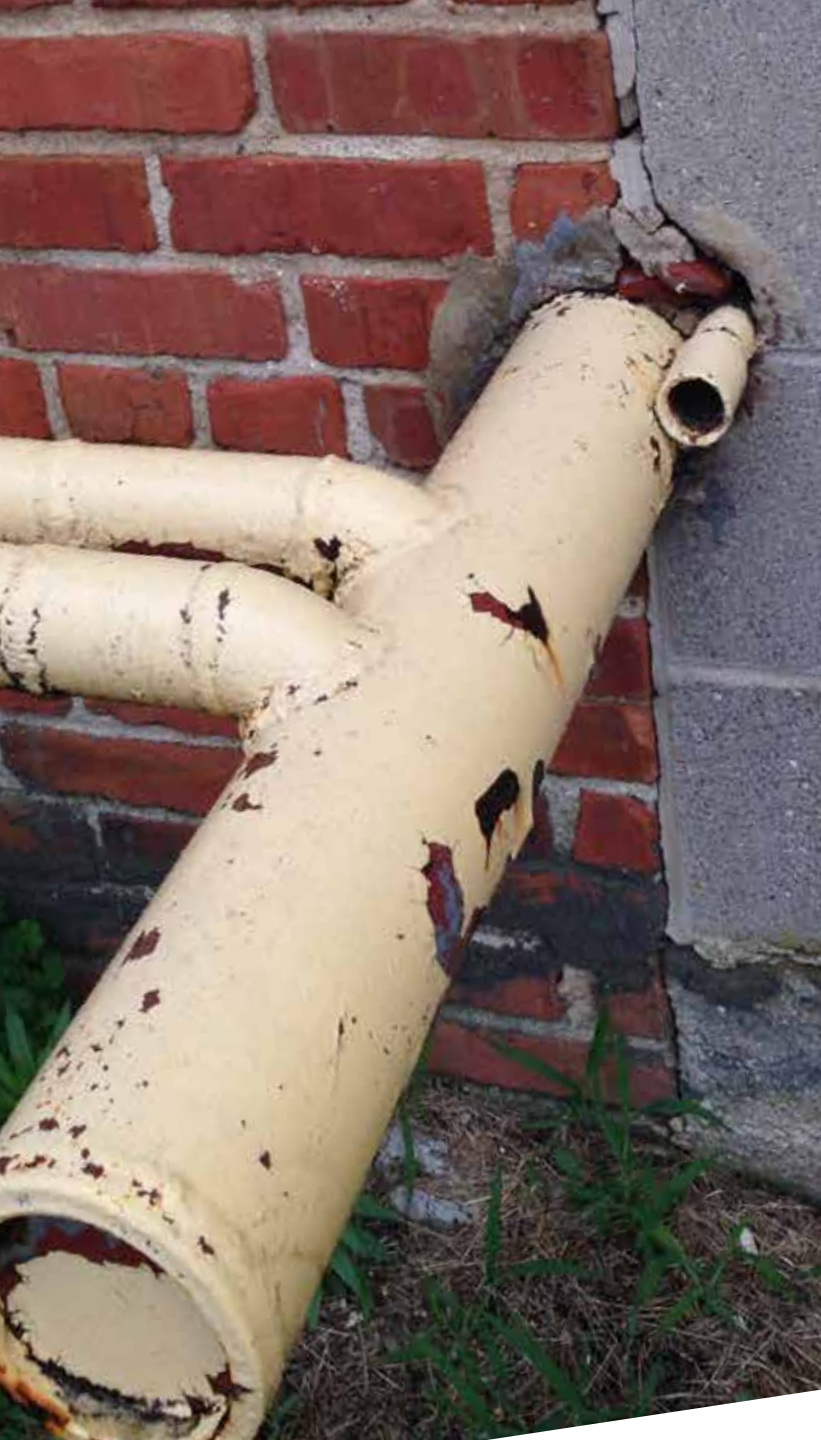
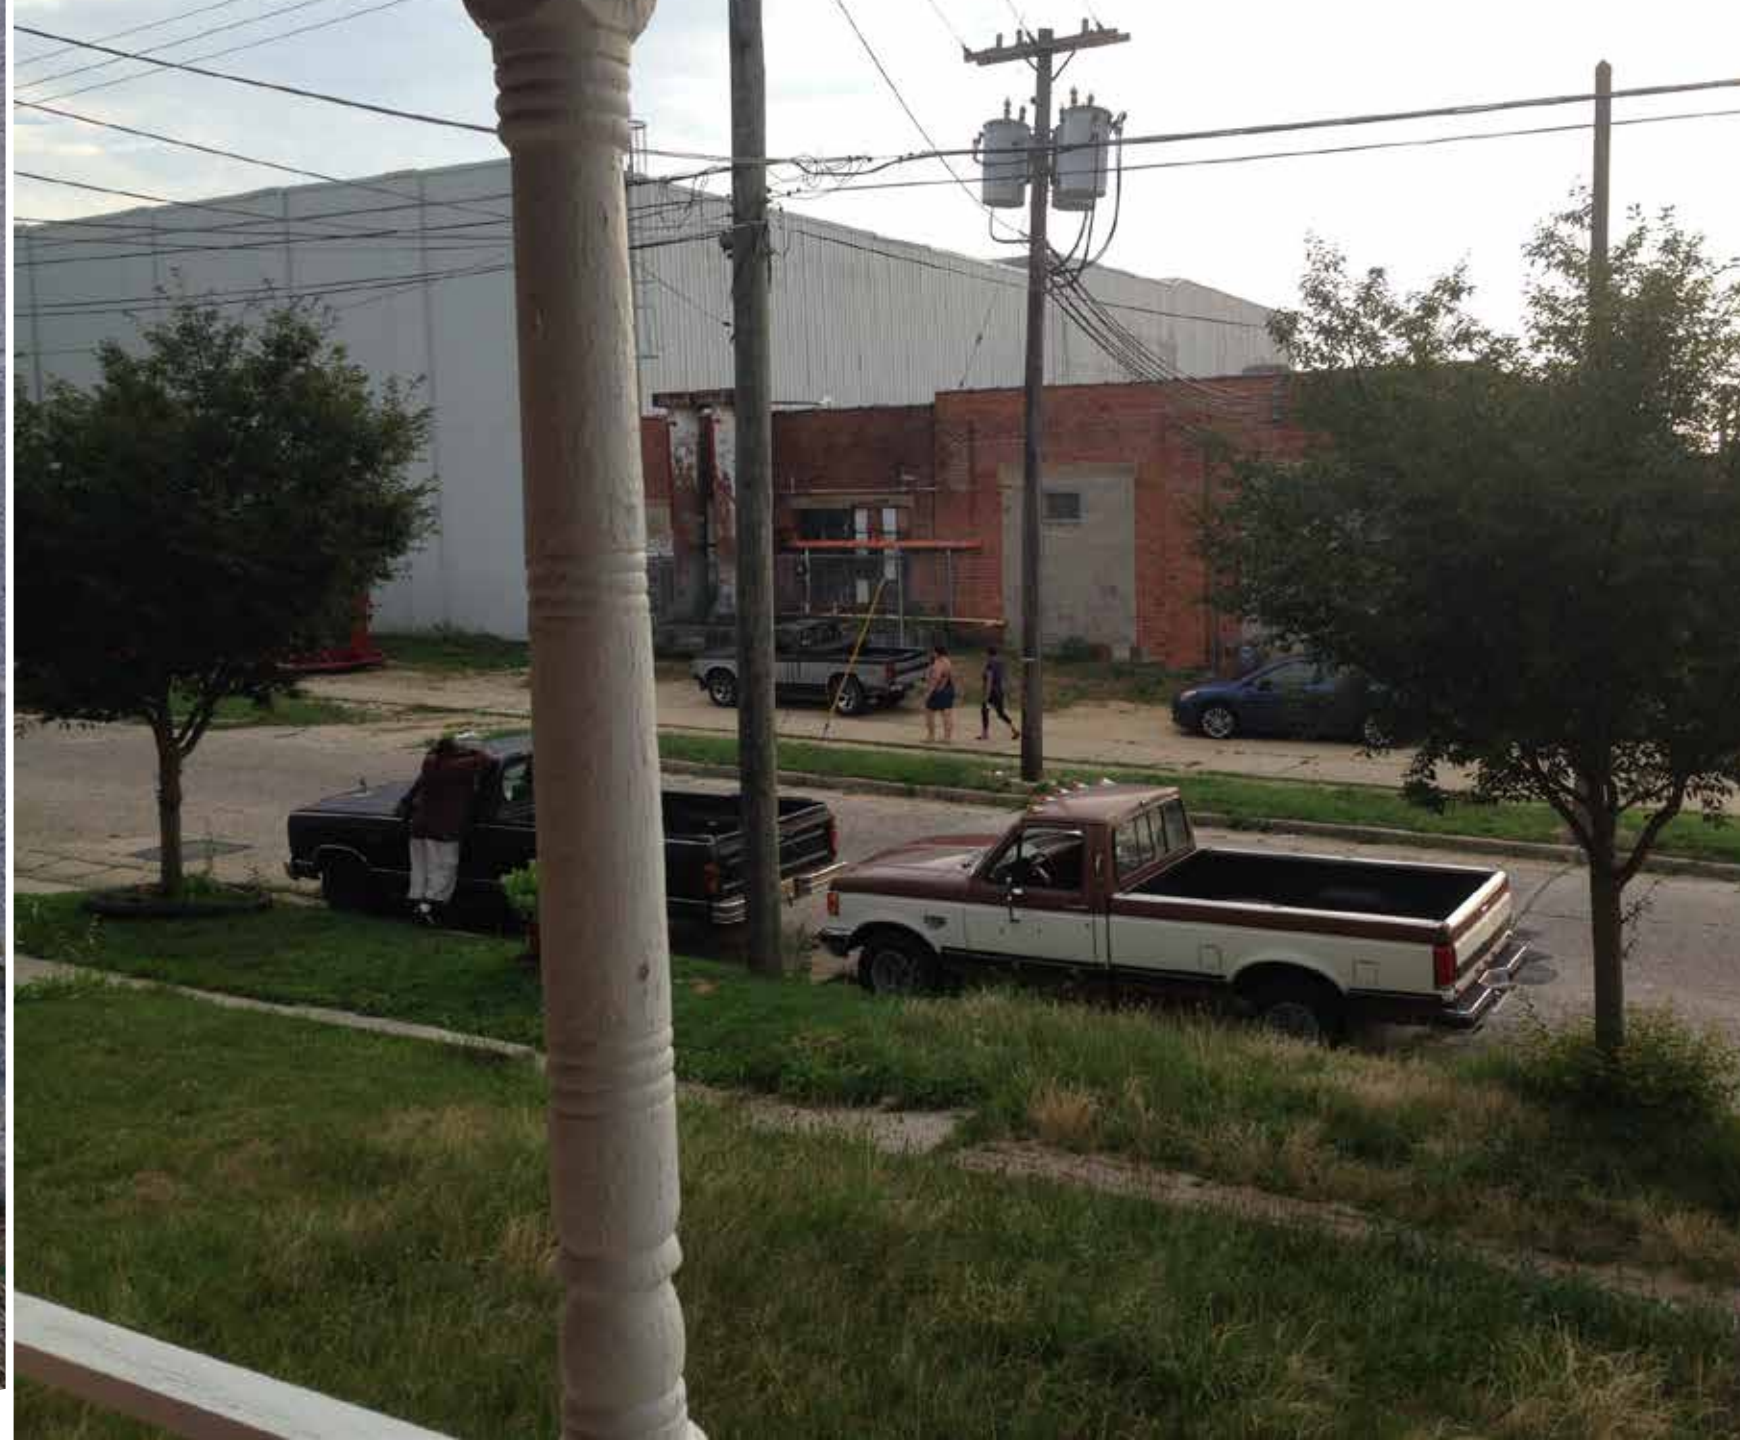
Initial assessment by EPA and facility owner refrigeration engineering contractors identify numerous serious deficiencies in the system and the need to remove the ammonia and repair the system as soon as possible.

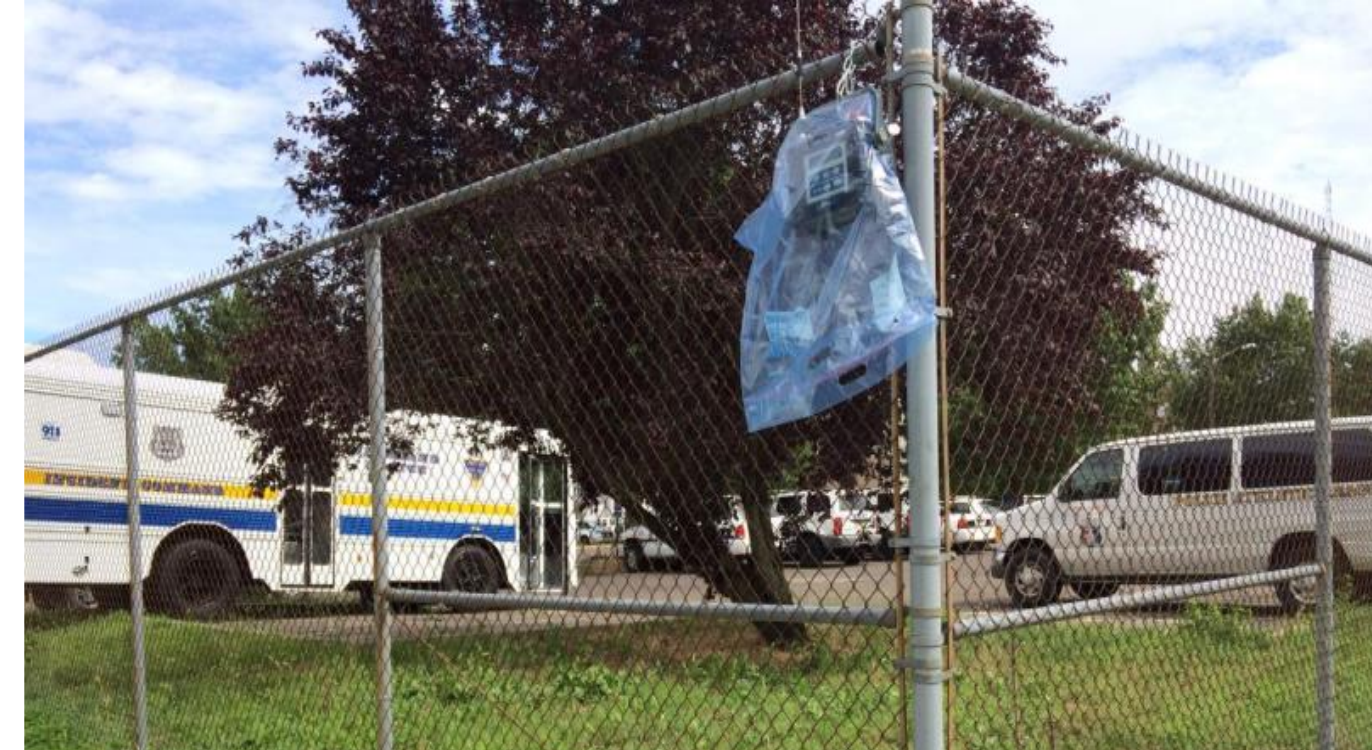
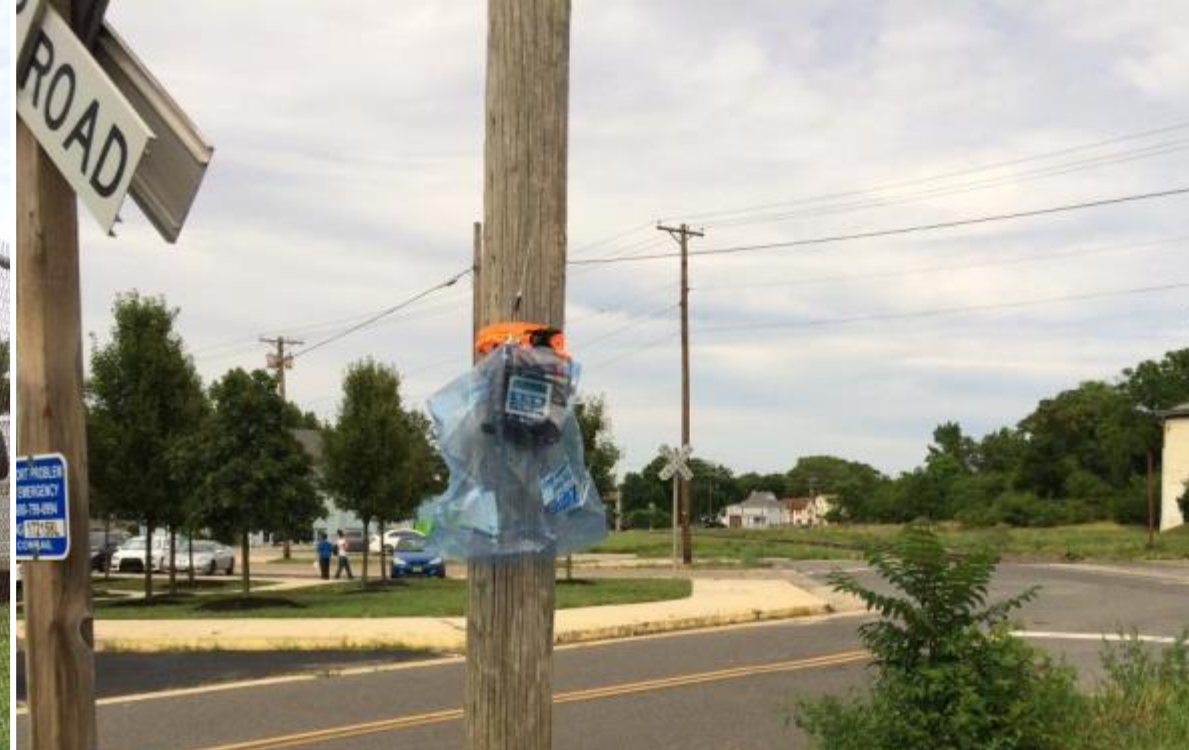
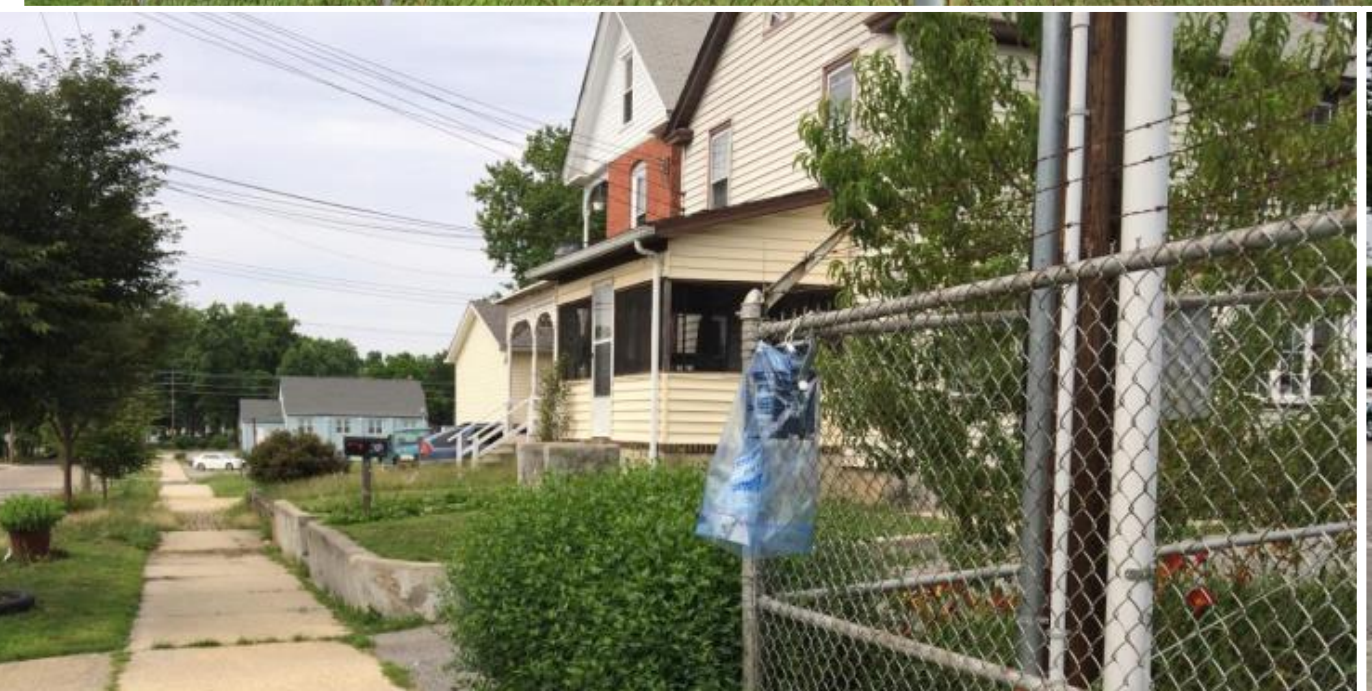
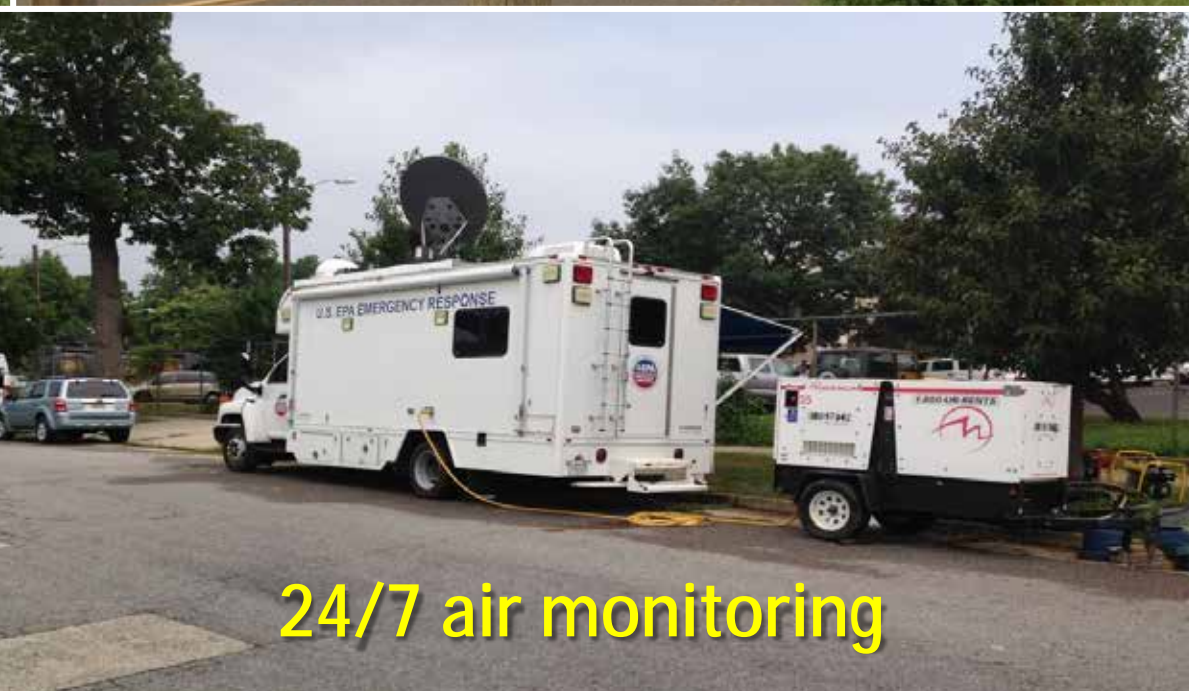
24/7 air monitoring

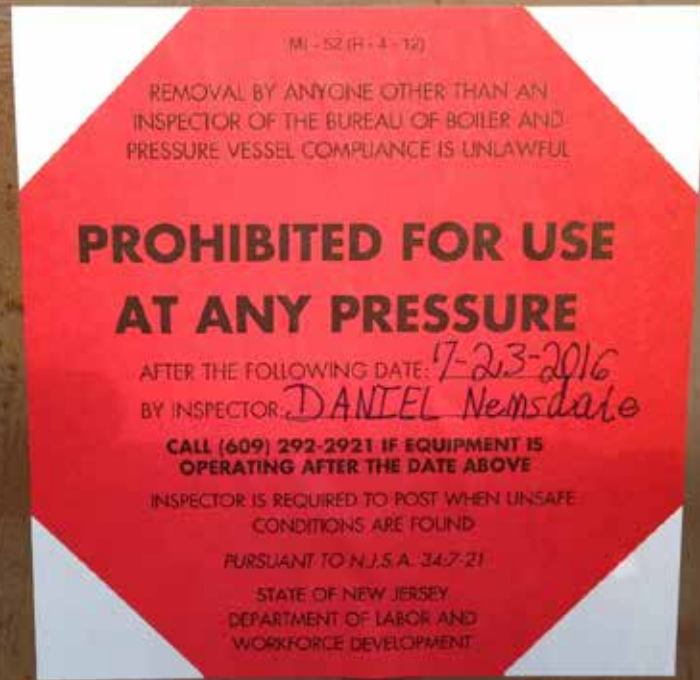
NJDOL Boiler
and Pressure Vessel
Red Tag 7/23/16
